# SWAB REPORT # 1117

# SWAB DATE: 22 April 2025

R/V Nathaniel B. Palmer

## REPORT FOR SWAB # 1117

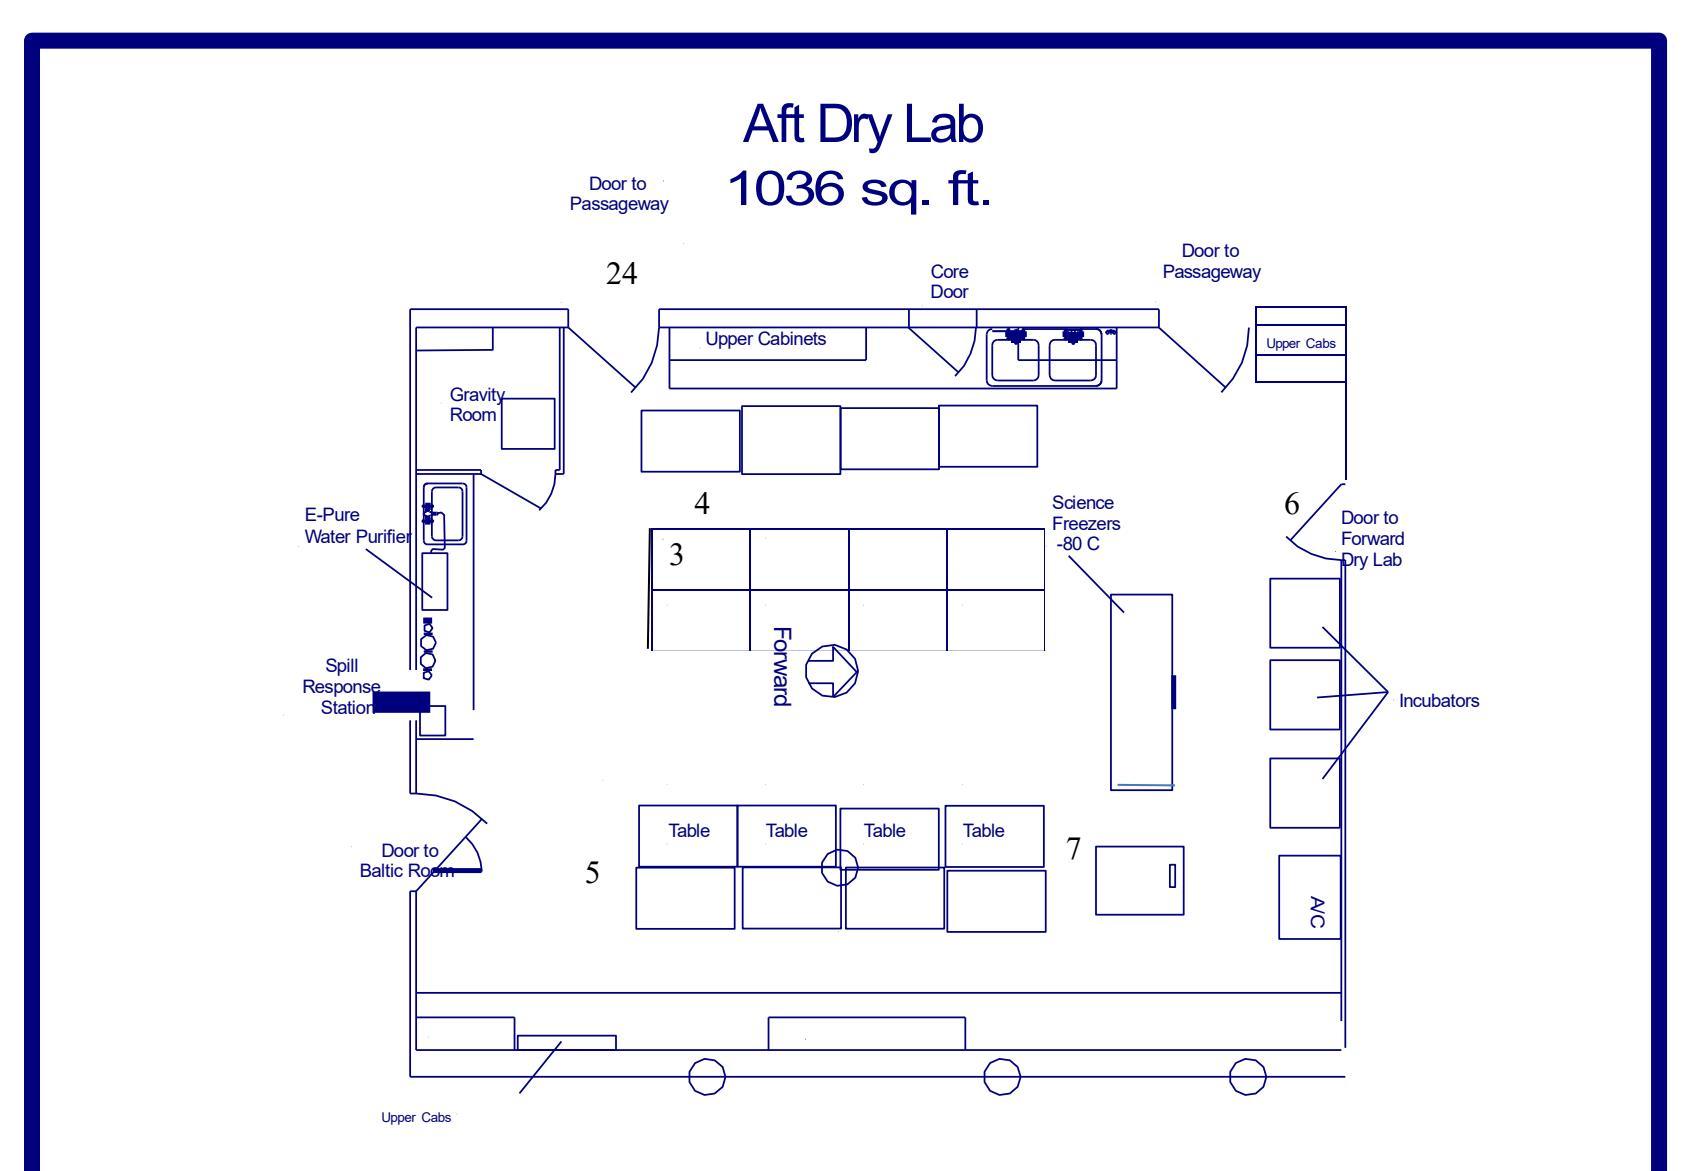
Figure 1 SWAB # 1117 22 April 2025

Sample # Sample Identification	<sup>3</sup> H dpm/m <sup>2</sup>			<sup>14</sup> C dpm/m <sup>2</sup>		
	activity	(	error	activity	activity er	
1 1st Vial Bkgnd	0	±	0	0	±	0
2 Initial bucket blank	20	±	26	-12	±	39
Aft Dry Lab (Figure 1)						
3 Bench top	5	±	6	28	±	16
4 Deck between the tables & corrosive chemical locker	26	±	24	-8	±	26
5 Deck by the Baltic Room door at the end of the tables	31	±	23	-5	±	15
6 Deck by the door to the forward dry lab	12	±	22	-4	±	13
7 Deckin front of the upright -20°C freezer	20	±	21	-1	±	23
Bio Lab (Figure 2)						
8 Deck in front of the starboard sink	19	±	24	-6	±	20
9 Table top forward	32	±	27	-14	±	46
10 Inside main door	22	±	26	-11	±	35
Forward Dry Lab (Figure 3)						
11 Deck in front of the light table	-6	±	100	4	±	16
12 Deck inside port entry door	27	±	26	-12	±	40
Electronics Lab (Figure 4)						
13 Deck by the entrance to the ET shop	28	±	31	-18	±	58
14 Deck in front of th printer on the starboard wall	14	±	32	-12	±	41

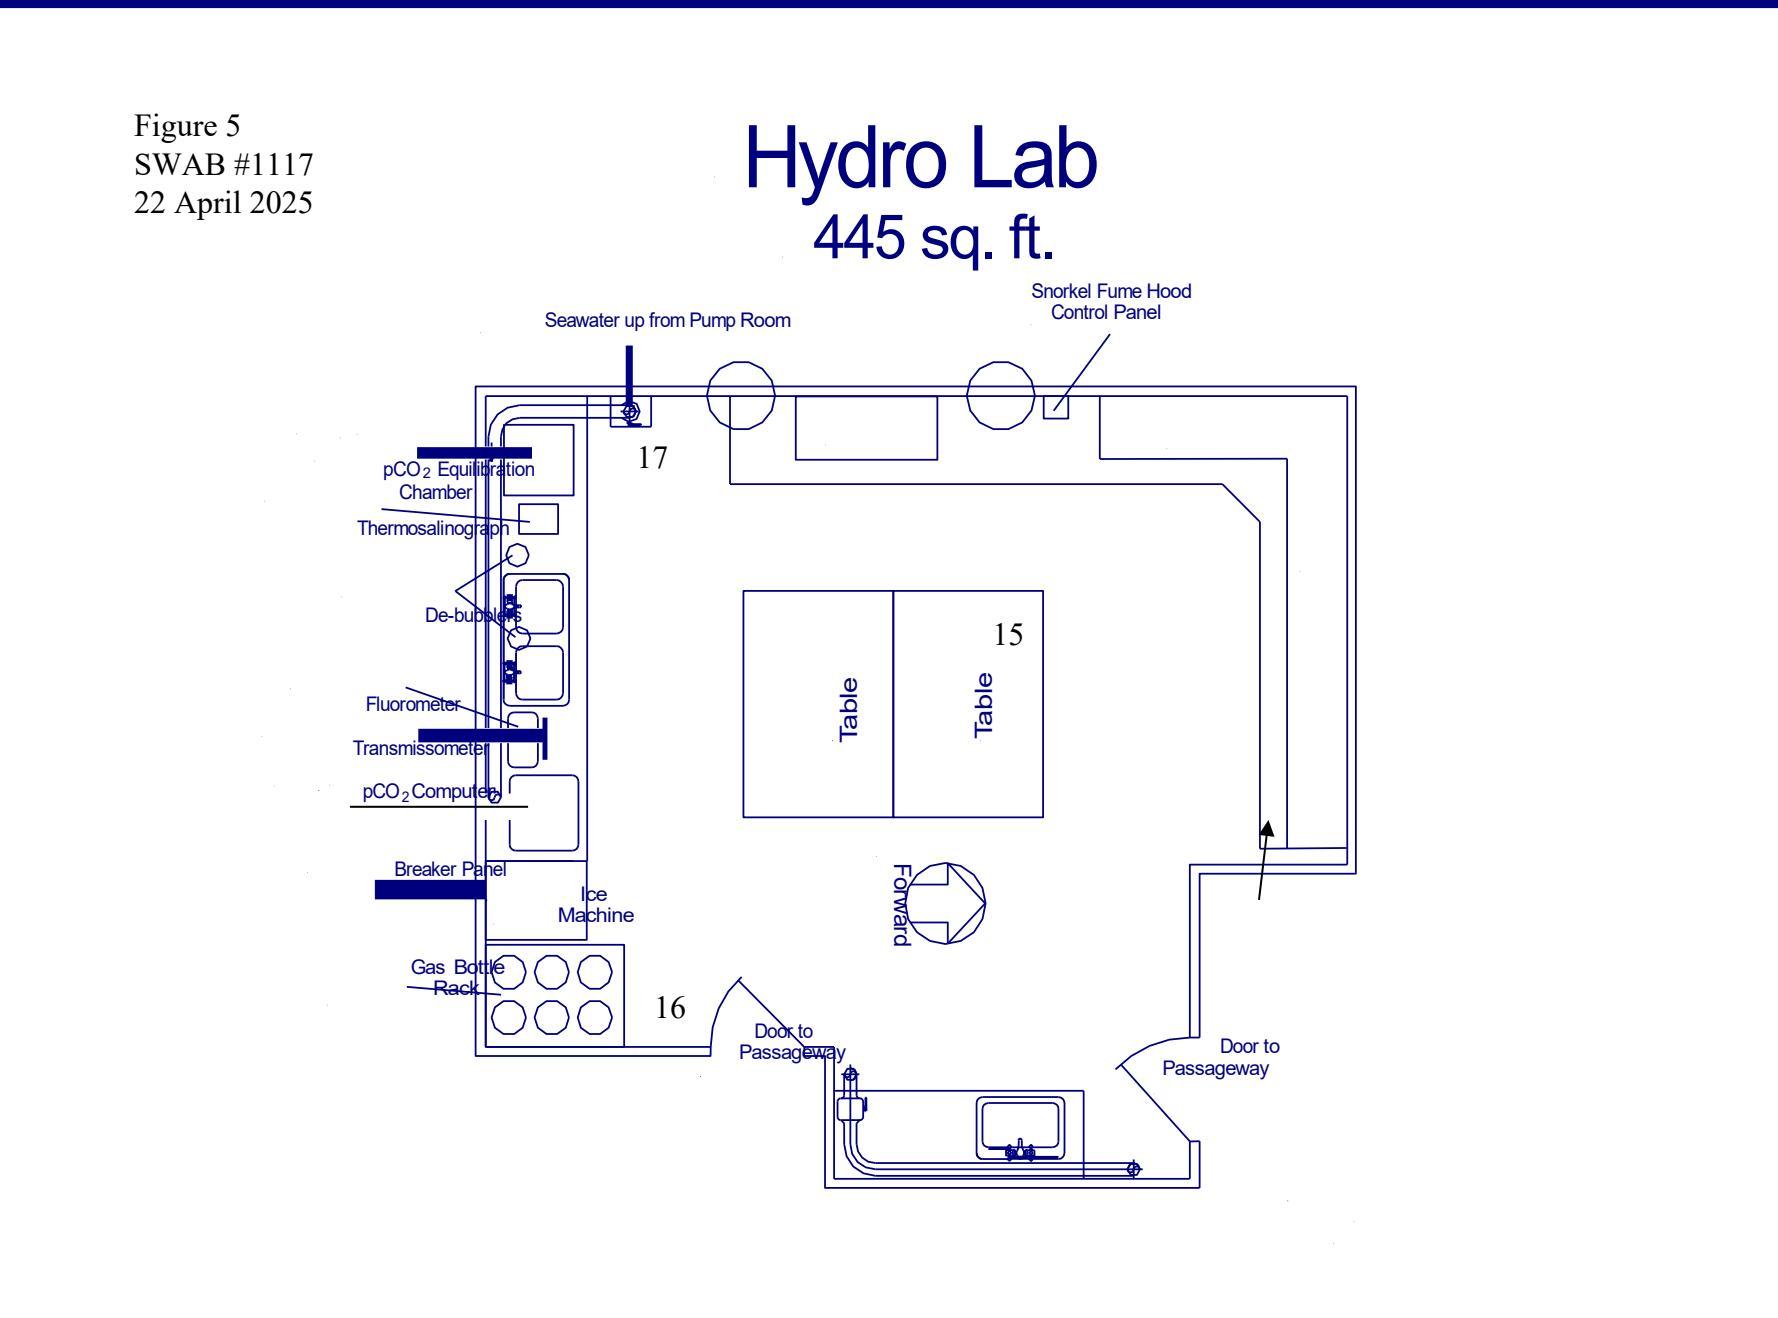
Hydro Lab (Figure 5)						
15 Table top portside forward	35	±	25	-3	±	11
16 Deck inside starboard entry door by the gas cylinders	18	±	31	-14	±	45
17 Deck in front of the ice machine	19	±	20	2	±	9
Wet Lab (Figure 6)						
18 Outside of the doorway toward Hydrolab	14	±	21	-3	±	9
19 Deck inside the forward door to passageway	12	±	19	3	±	12
Rad Van 2 (Figure 7)						
20 Deck in front of the waste drums	387	±	55	29	±	10
21 Deck in front of the LSC	96	±	31	10	±	11

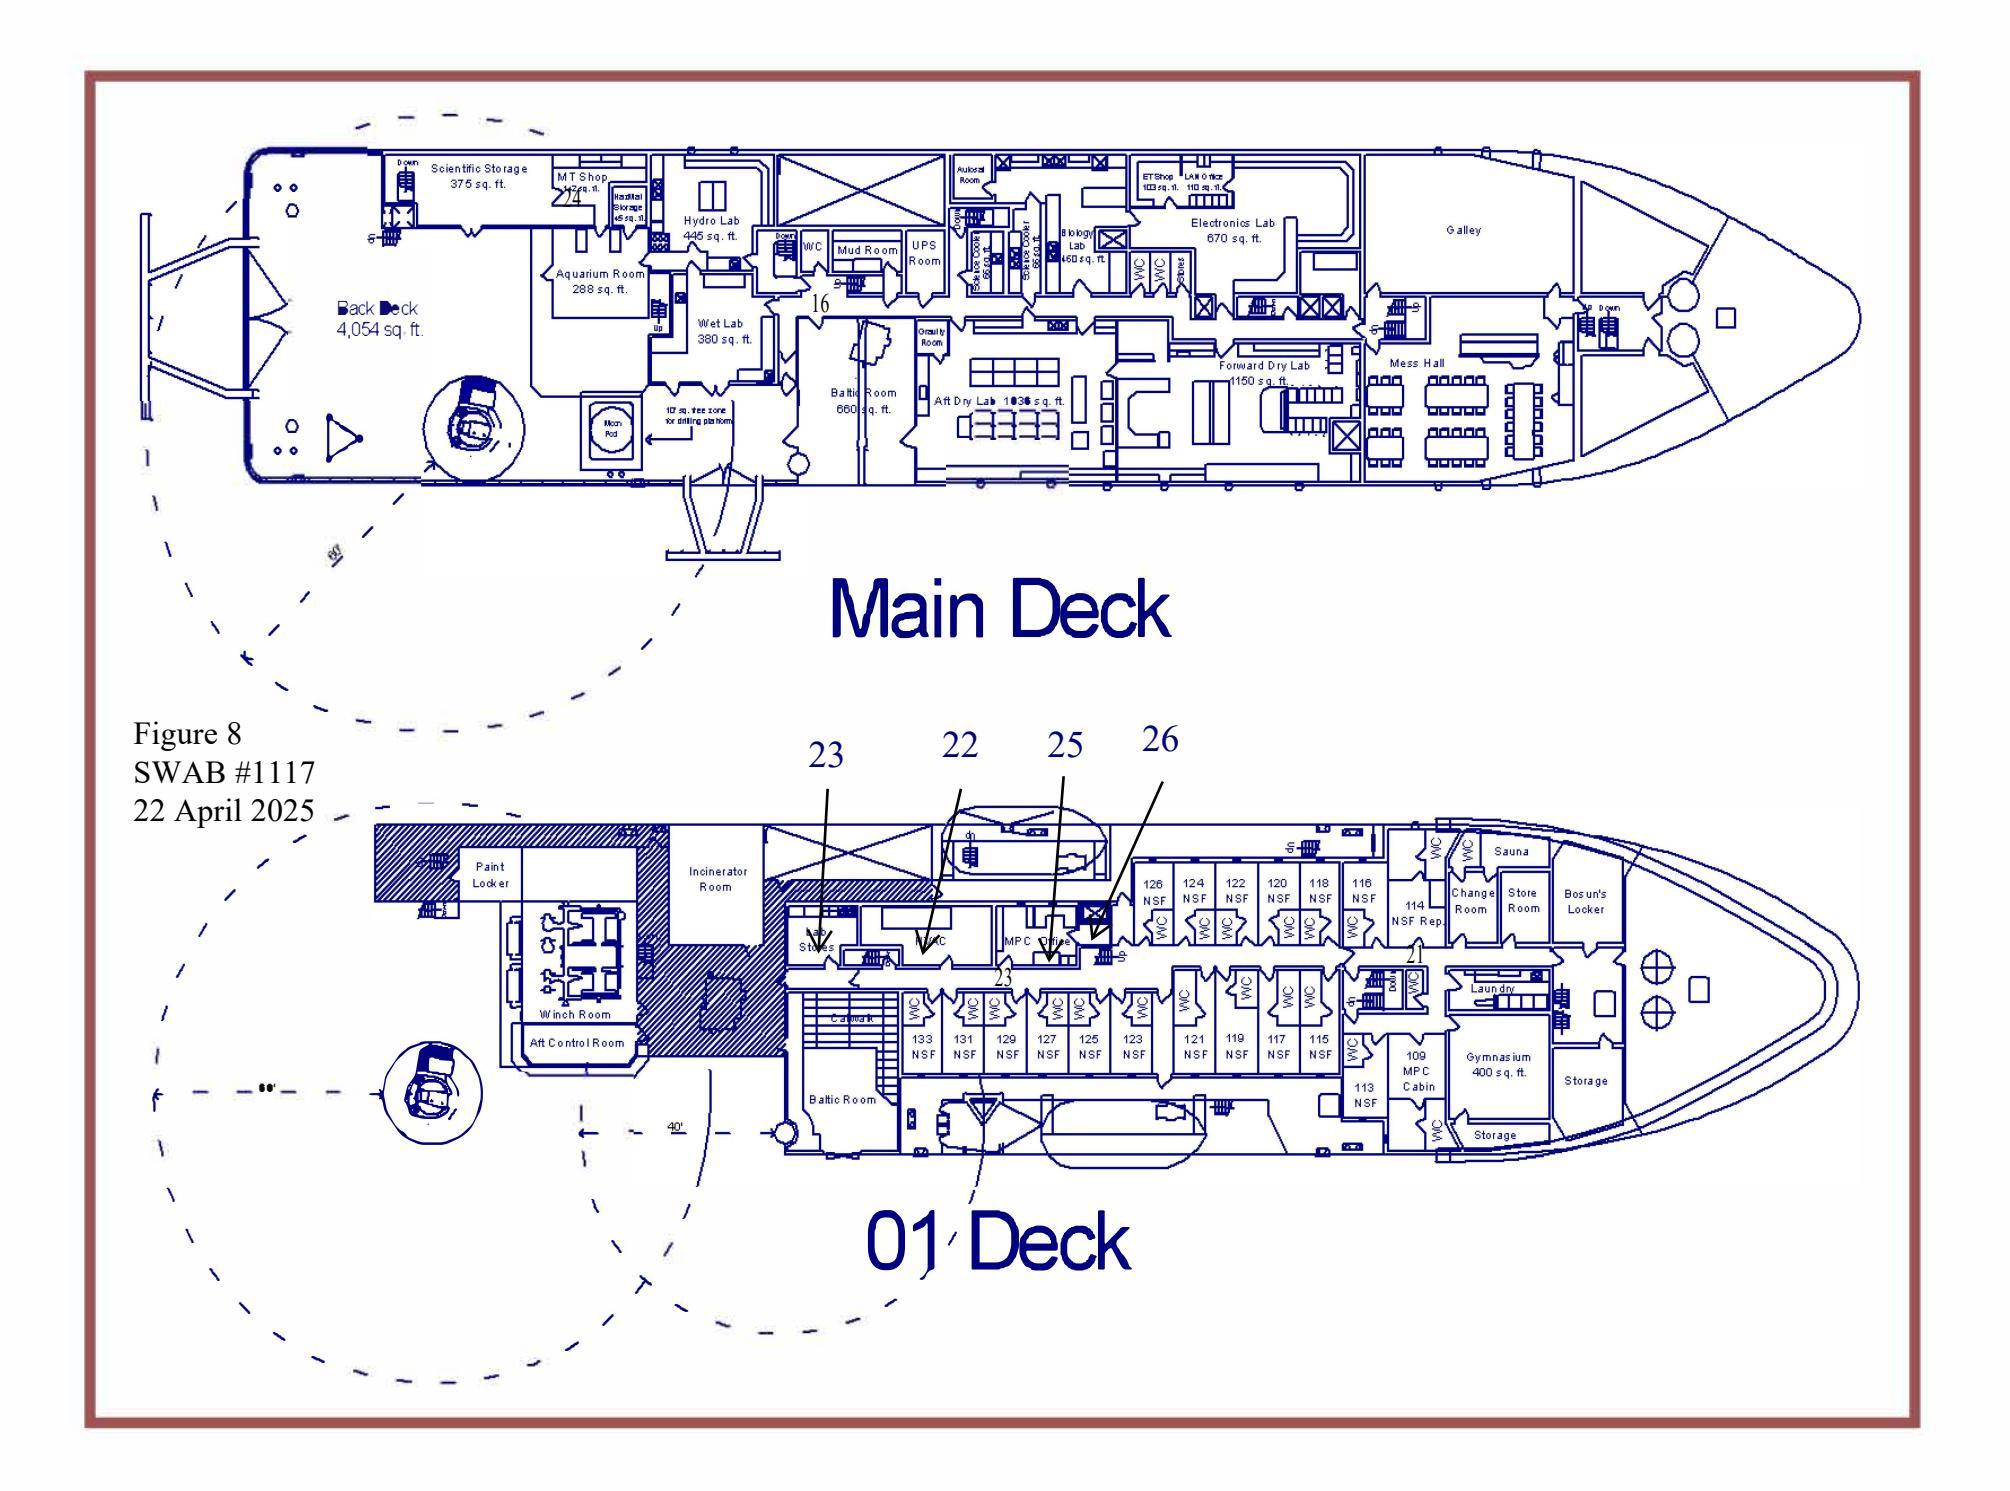
Sample # Sample Identification	<sup>3</sup> H dpm/m <sup>2</sup>			<sup>14</sup> C dpm/m <sup>2</sup>		
	activity	(	error	activity	error	
Main Deck (Figure 8)						
22 Aft stairs at bottom of the stairway	10	±	31	-8	±	27
23 MLT office door inside of office	4	±	58	-5	±	17
24 Mudroom entryway in front of the waterbaths	24	±	41	-21	±	69
25 Deck inside the MPC office at entry	43	±	27	-7	$\pm$	24
26 Deck at the bottom of the stairway to Helo hangar	27	±	33	-23	±	76
Helo Deck and Hangar (Figure 9)						
27 Helo deck in front of the waste drums	-6	±	93	3	$\pm$	16
28 Helo deck outside of RV personnel door	13	±	34	-13	±	42
29 Helo deck aft in front of starboard incubator	7	±	42	-8	±	28
30 Helo hangar workshop in front of sink	-14	±	228	-14	±	47
31 Hood in Rad Van 2	113	±	34	-1	±	3
32 Refrigerator in Rad Van 2	240	±	45	7	±	6
33 Final bucket blank	3	±	52	-8	±	25
