SWAB REPORT # 853

R/V Hugh Sharp

REPORT FOR SWAB # 853

LOCATION: Lewes, DE VESSEL: *Hugh Sharp* DATE: 24 February 2017 TECHNICIAN: Yudy Mendoza

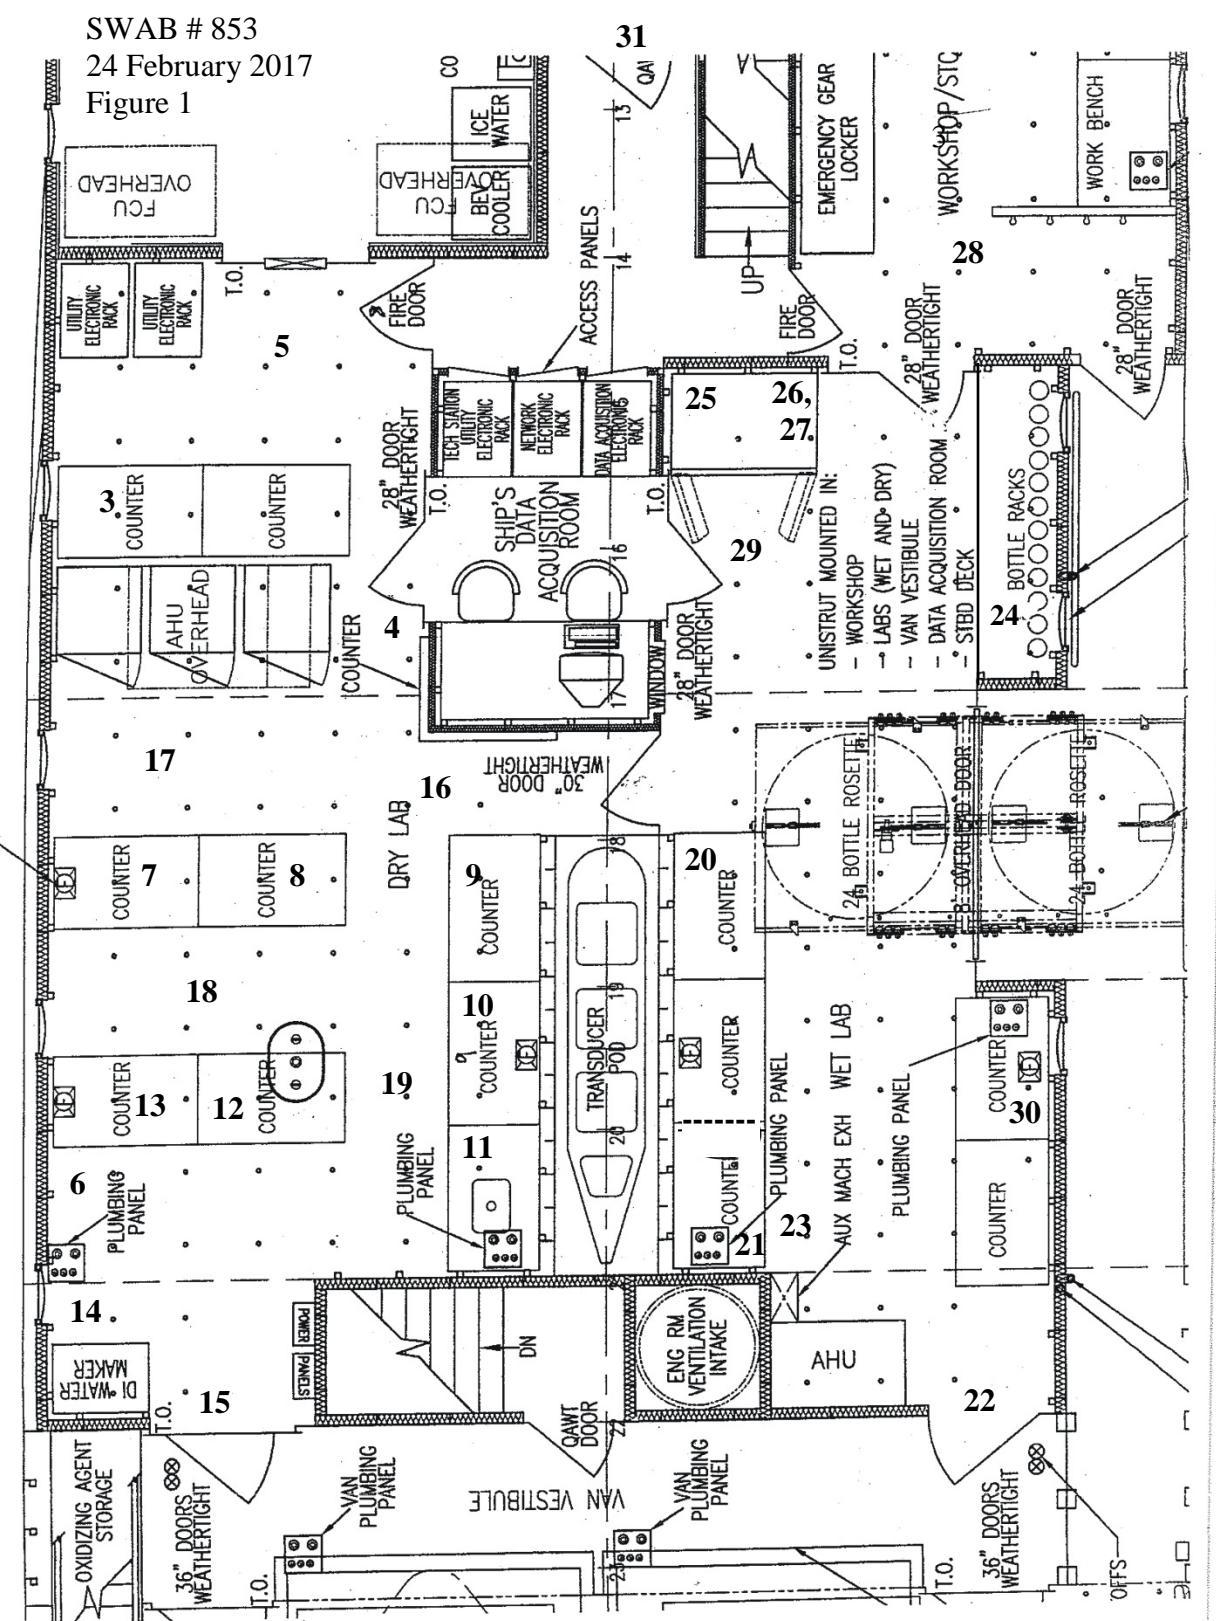
Please note that the error reported for each isotope is the two-standard deviation counting error. The reports may now contain values less than zero. When decay counting background samples will be distributed about the background vial, which means that negative values are possible. In the past we rounded the negative values to zero. Values are only significantly above background when they are positive and larger than the error. All areas tested on the ship were free from any isotope contamination that requires cleaning. **RV Hugh Sharp Lab Spaces**
