Tritium Laboratory
19 December 2022

SWAB REPORT # 1048

R/V Savannah

LOCATION: Savannah, GA
VESSEL: R/V Savannah

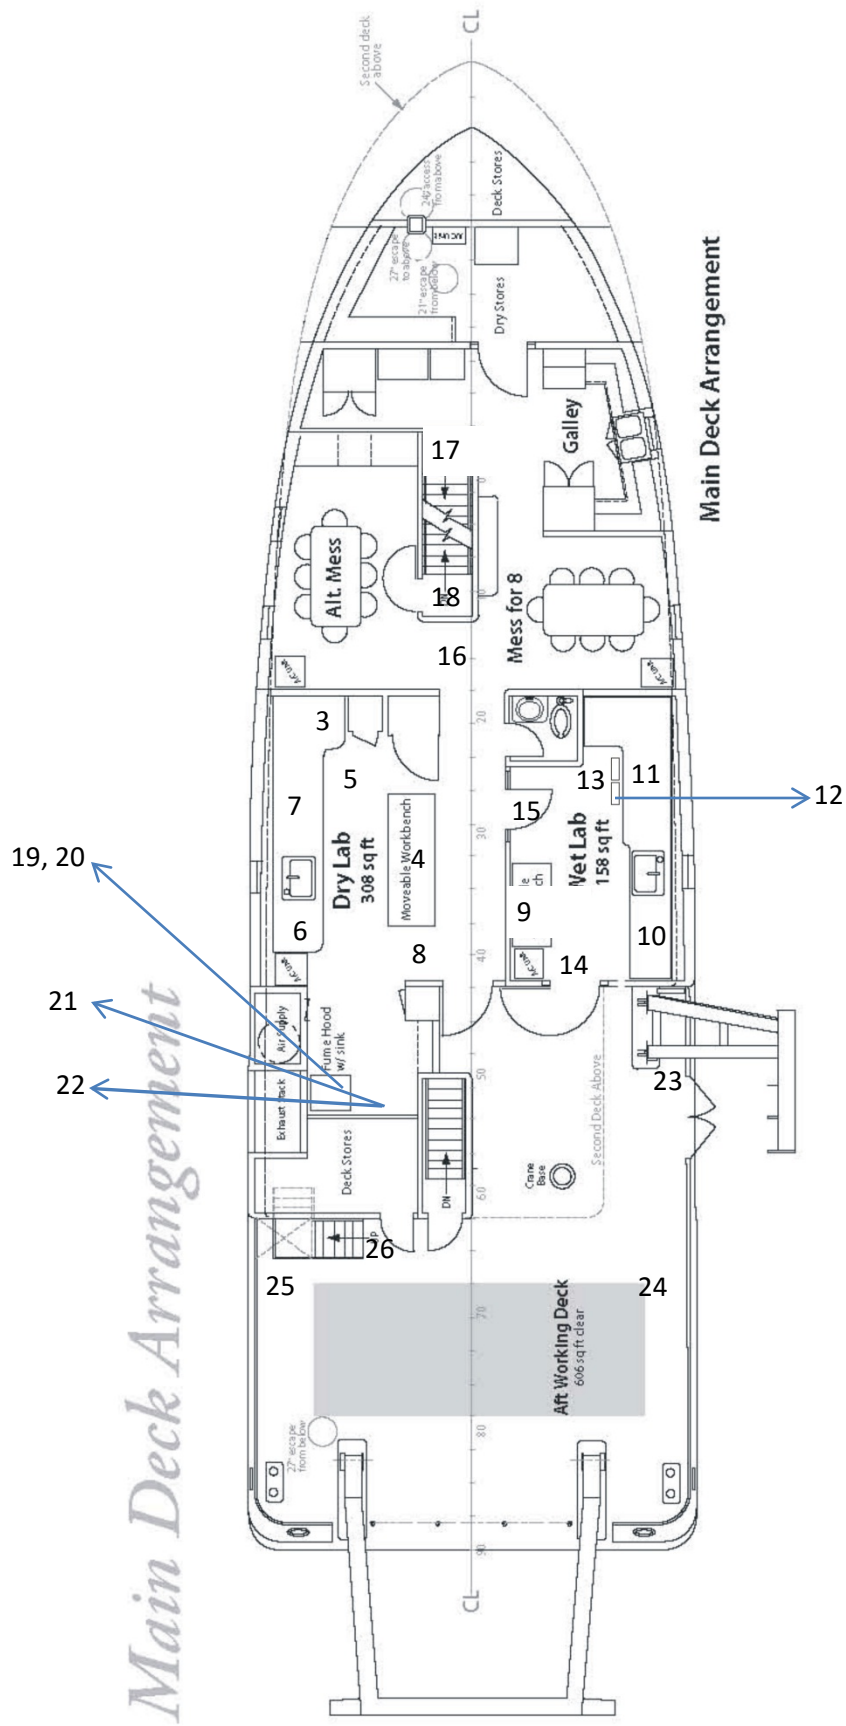
Figure 1
 SWAB #1048
 8 December 2022

Sample #	Sample Identification	³ H dpm/m ²		¹⁴ C dpm/m ²	
		activity	error	activity	error
1	1st Vial Bkgnd	0	± 0	0	± 0
2	Initial bucket blank	-38	± 78	-8	± 24
	<u>Dry Lab (Figure 1)</u>				
3	Forward benchtop	4	± 54	-4	± 12
4	Center benchtop	-35	± 71	2	± 6
5	Forward deck	19	± 39	-6	± 19
6	Port benchtop aft of sink	1	± 9	-18	± 29
7	Port benchtop forward of sink	-23	± 47	-11	± 17
8	Deck at aft entrance	-63	± 128	11	± 18
19	Inside fume hood	-14	± 28	-17	± 20
20	Benchtop next to fume hood	-19	± 38	-8	± 13
21	Deck in front of fume hood	-73	± 148	21	± 17
22	Inside refrigerator	-3	± 33	2	± 13
	<u>Wet Lab (Figure 1)</u>				
9	Port benchtop	-6	± 77	-13	± 15
11	Benchtop forward of sink	-41	± 84	-4	± 6
10	Benchtop aft of sink	-33	± 68	13	± 15
12	Inside Summit refrigerator	28	± 48	-19	± 22
13	Deck in front of Summit refrigerator	-22	± 44	-12	± 15
14	Deck at aft entrance	-26	± 54	3	± 21
15	Deck inside port entrance	-43	± 88	14	± 16

<u>Miscellaneous Areas (Figure 1)</u>				
16	Deck in front of water fountain	-19	± 38	2	± 24
17	Deck at bottom of stairs	-29	± 59	0	± 43
18	Deck at top of stairs	-60	± 121	19	± 16
	<u>Aft Deck (Figure 1)</u>				
23	Deck near CTD	-56	± 115	13	± 17
24	Deck near incubator on Starboard side	-58	± 118	11	± 17
25	Deck near incubator on port side	-53	± 107	7	± 20
26	Deck at base of stair to 01 Deck	-55	± 111	21	± 16
27	Final bucket sample	-19	± 39	-4	± 7

Please note that the error reported for each isotope is the two-standard deviation counting error. Reports may now contain values less than zero. Decay counting background samples will be distributed about the background vial, which means that negative values are possible. In the past we rounded the negative values to zero. Values are only significantly above background when they are positive and larger than the error. Please note that we are now using a Quantulus 6220 LSC which counts very near natural background. While the cleanup standards have not changed all values above background will now be in bold. The benchtops and galley deck were freshly painted on the ship. All areas sampled were free from isotope contamination that requires cleaning.
