**Naval Architects & Salvage Engineers**

## **NSF SHIP INSPECTION PROGRAM**

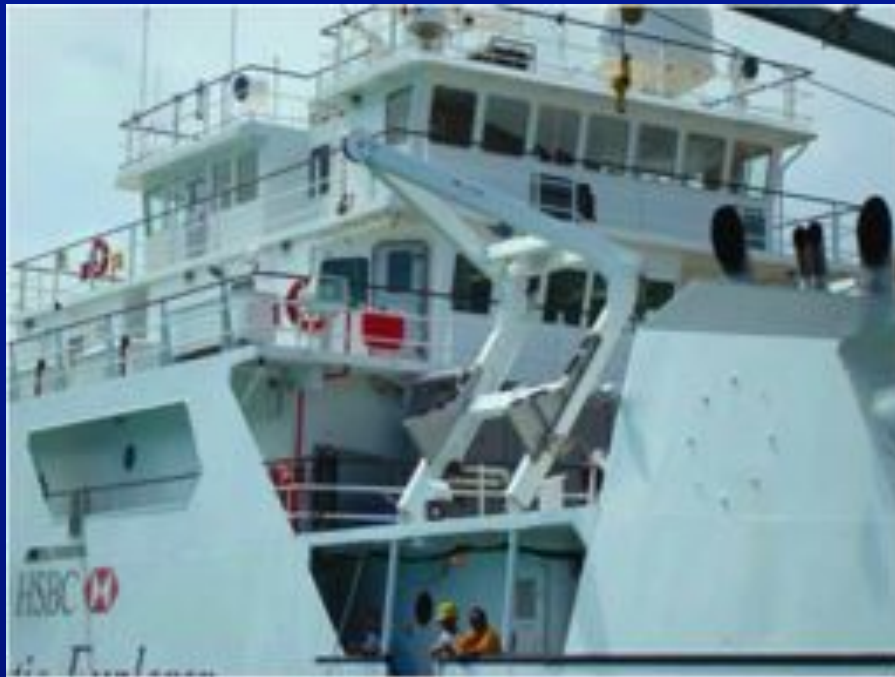
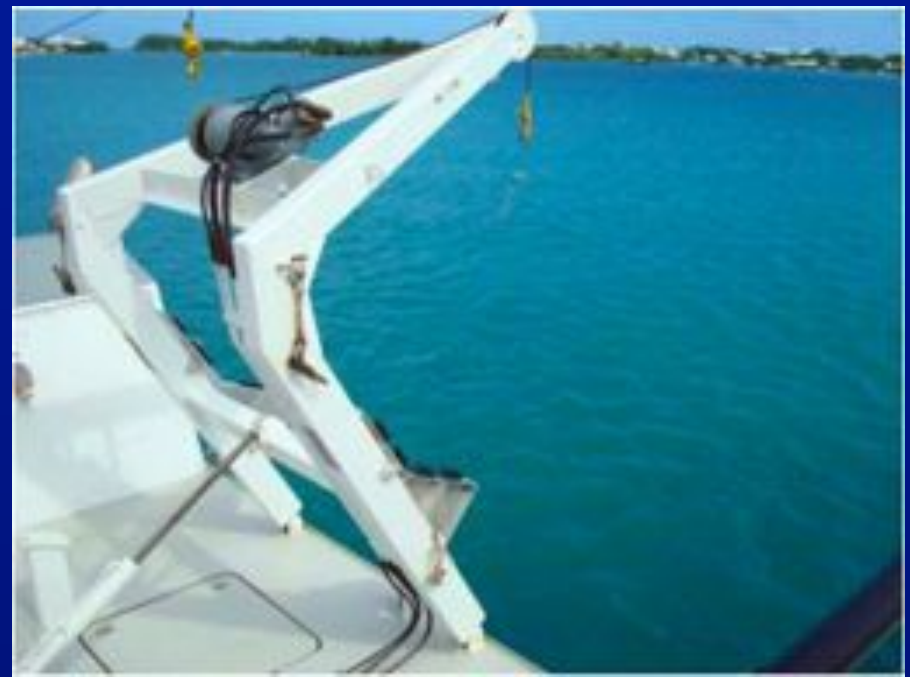
## RV Atlantic Explorer Workboat Davit

The vessel has a dedicated davit for the workboat similar to SOLAS rescue boat davits. Most UNOLS vessels store their work boat on the port side of the vessel and use a starboard side or centerline crane to launch and recover it. This requires several people with tag lines passing the vessel across multiple decks and around many obstructions including the stack, vans, railings, etc. A dedicated davit allows for a faster and safer deployment by fewer crew members.

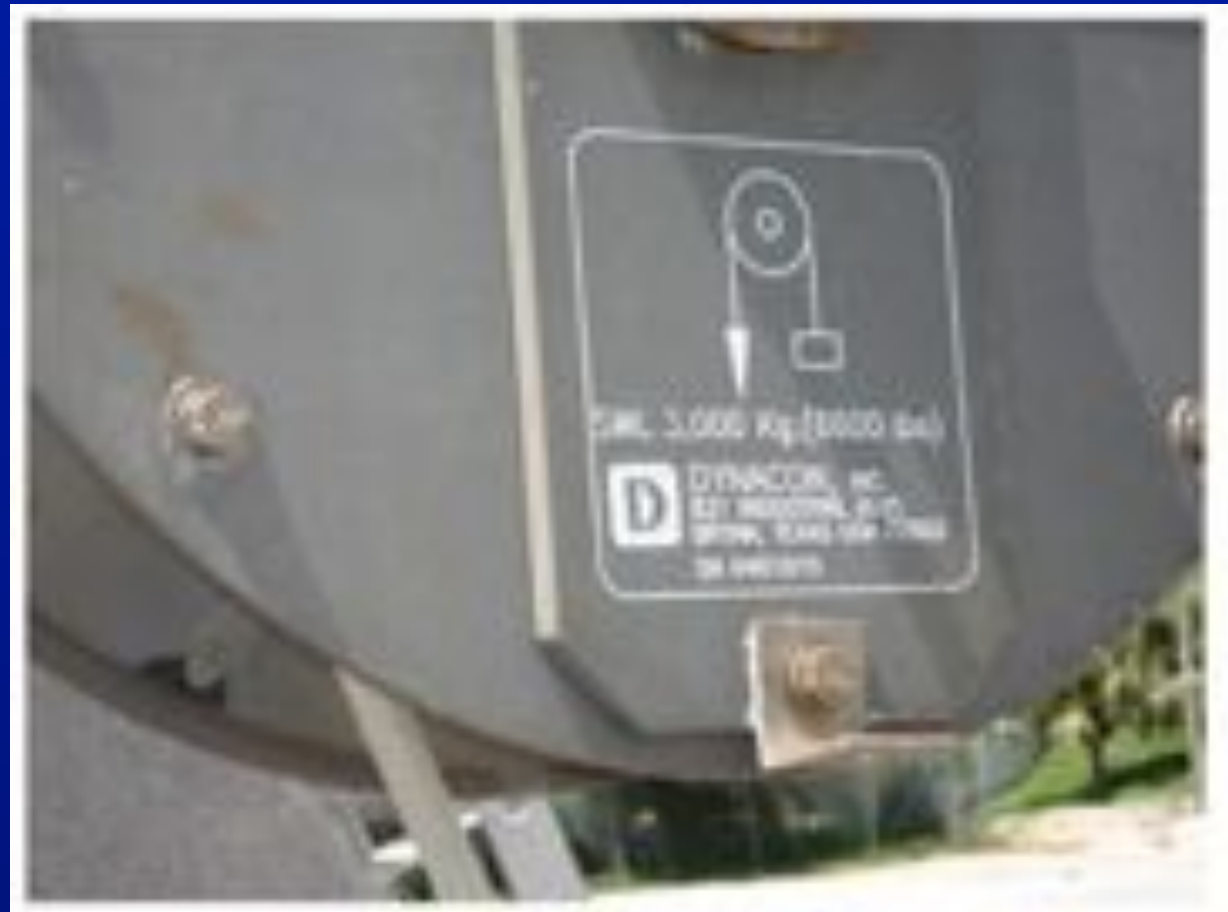
## RV Atlantic Explorer MPT Placard

Block Placard -  
"Maximum  
Permissible  
Tension"  
placard on a  
block which  
may be a future  
requirement of  
Appendix B.

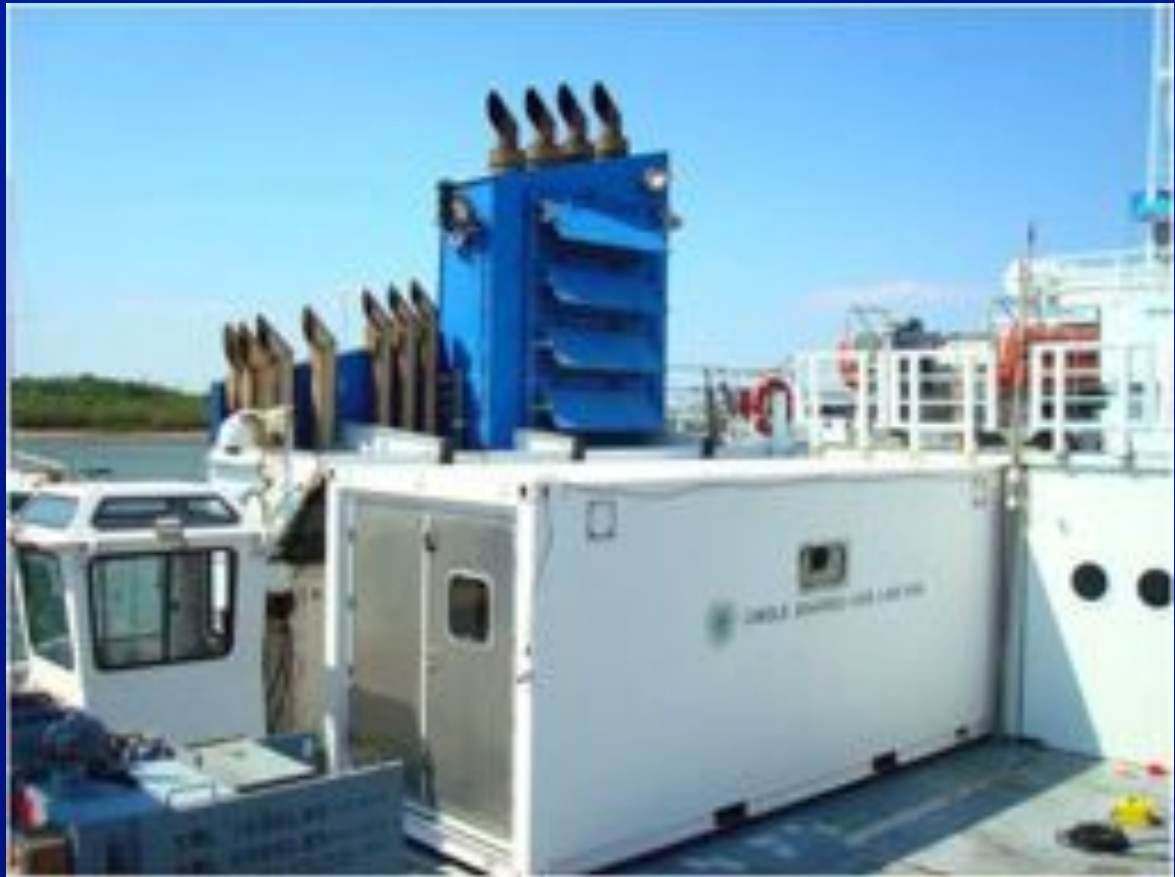
## RV SHARP Van Vestibule

The ship can accept two vans on its aft main weather deck connected to the ships interior through a vestibule. The system is designed to accept 20 ft. vanpool vans with the entry door leading into a vestibule so personnel do not go outside when entering the vans.

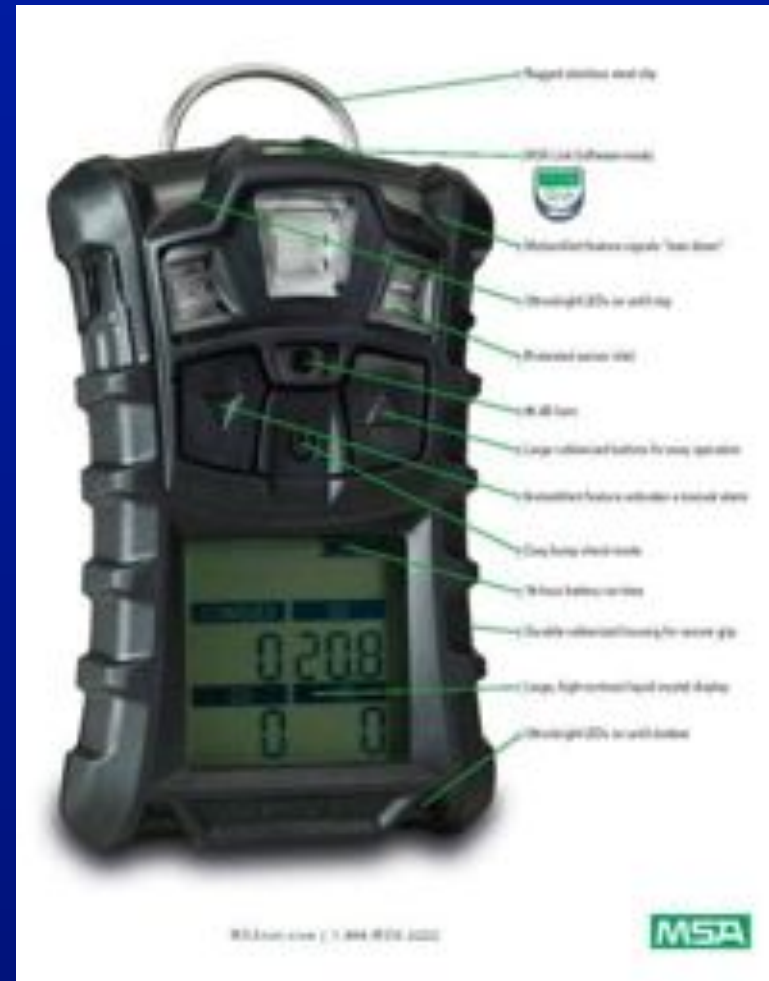
## RV SHARP Gas Detector

The vessel uses a relatively inexpensive Mine Safety Appliance [MSA] Altair 4 portable/personal gas detector for confined space entry and overhauling fire scenes. The meter detects LEL, CO, H2S, and O2.

The rubber over-molded housing is easy to grip, durable, and small enough to be lowered on a line into the tank or clipped to your shirt.

Most UNOLS vessels have a gas detector that was part of a group purchase several years ago. These units have a history of sensor failures and calibration issues.

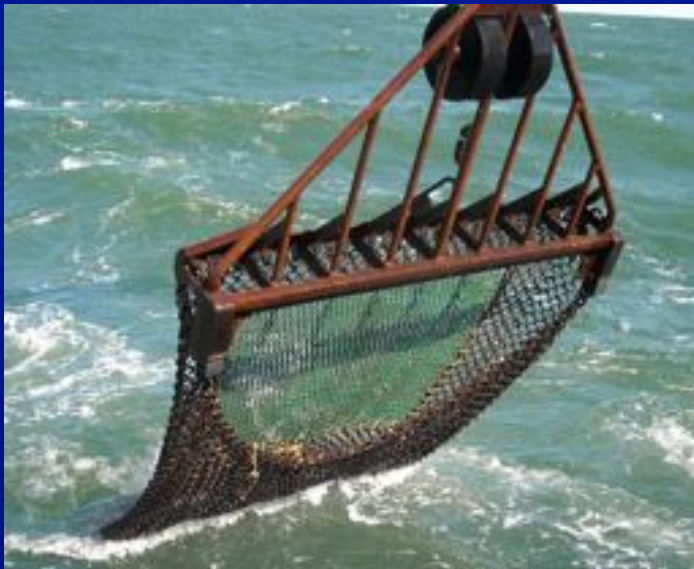
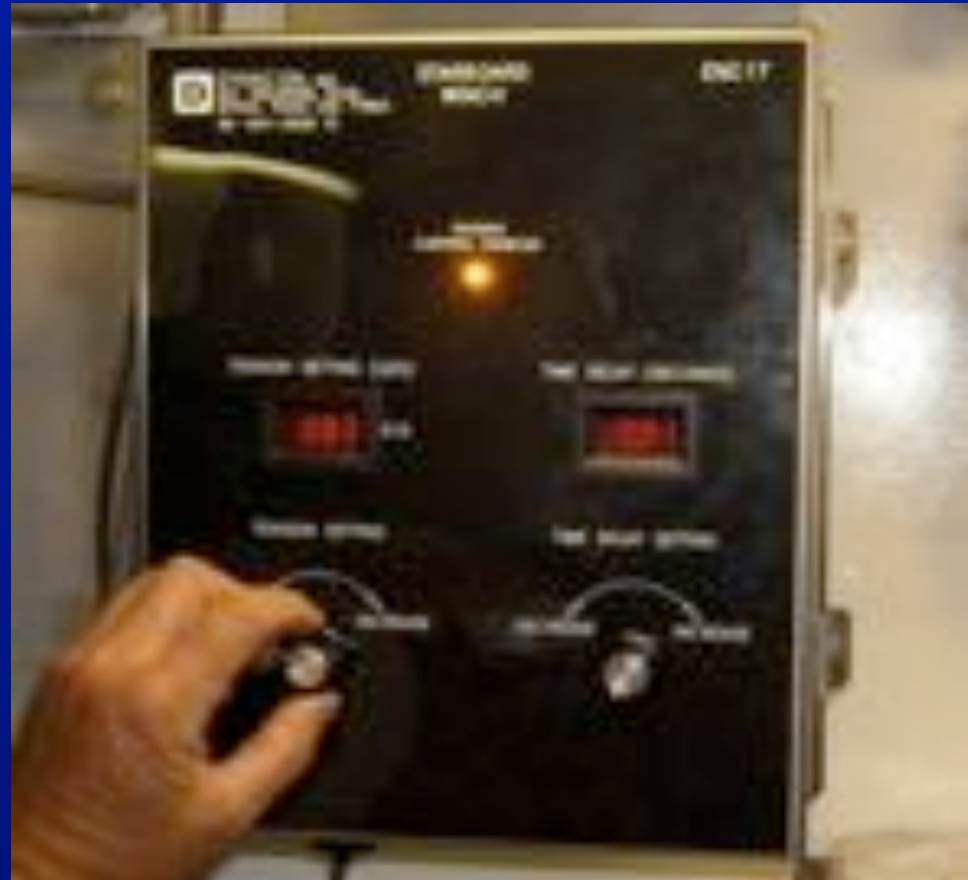
# Sample Best Practice RV SHARP Render / Recover

Render-Recover mode on trawl winches

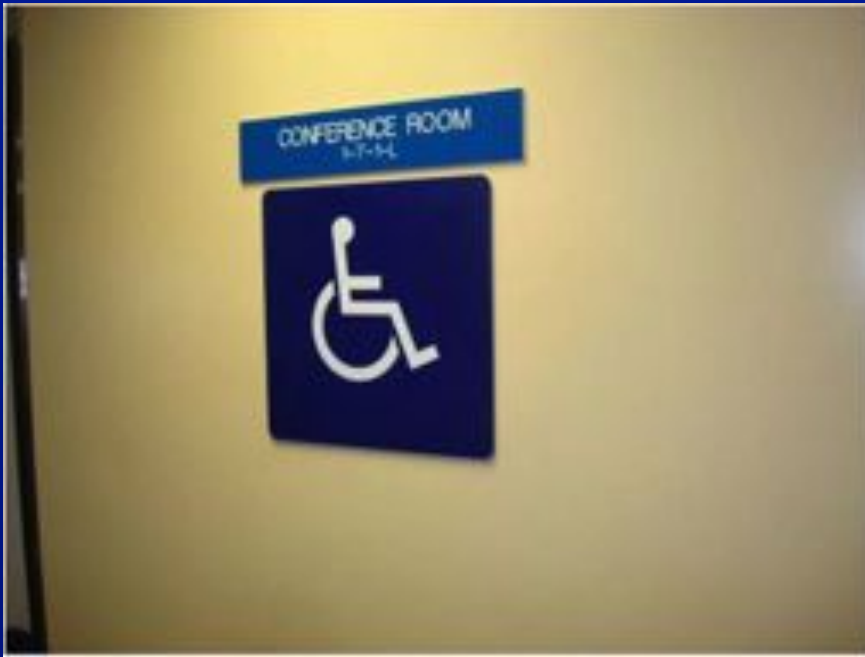
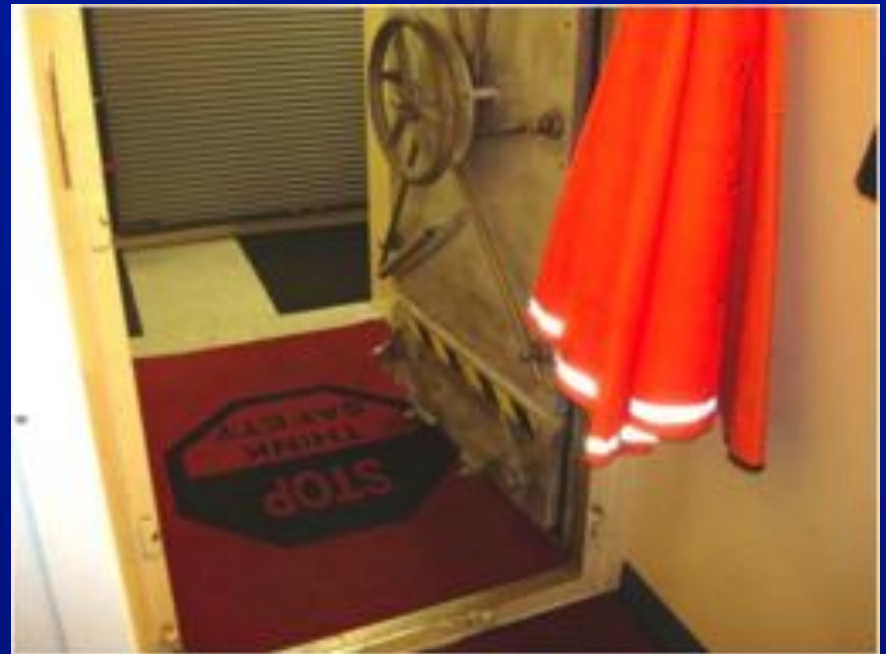
## RV SHARP ADA Features

The vessel was designed to incorporate ADA features. Watertight door thresholds can be removed for easier access on the Main Deck. A handicap accessible stateroom and head as well as labs and the mess deck are easily accessible on the Main Deck. The general alarm has visual beacons as well as an audible alarm.
