*MC-800 Multicorer
with Real-Time
Camera, CTD and
Water Sampling
Capability for the
UNOLS Community*

Dan Fornari
Joan Bernhard
Ginny Edgcomb
WHOI

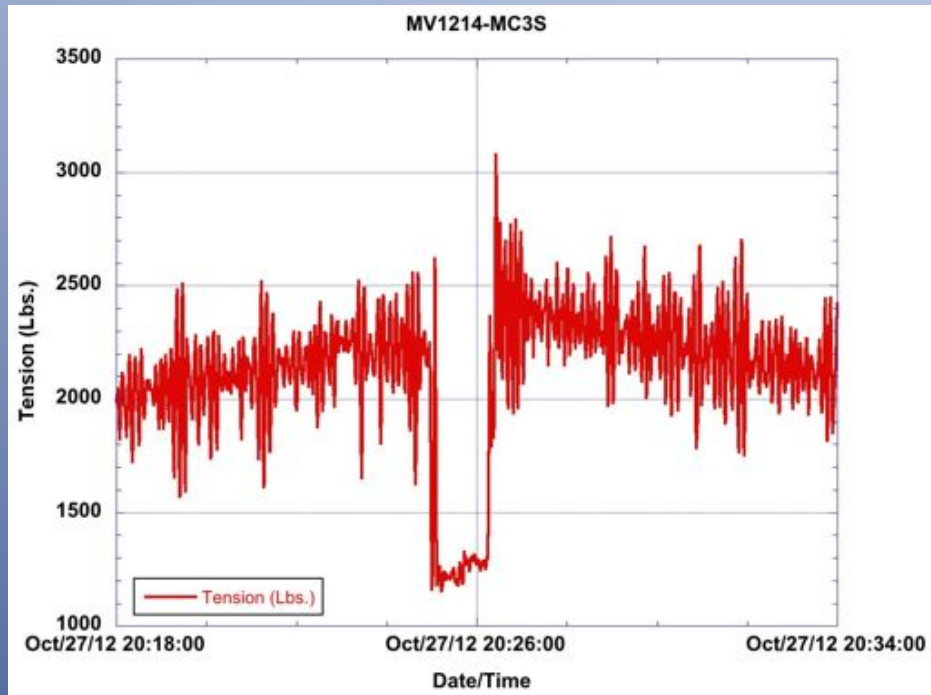
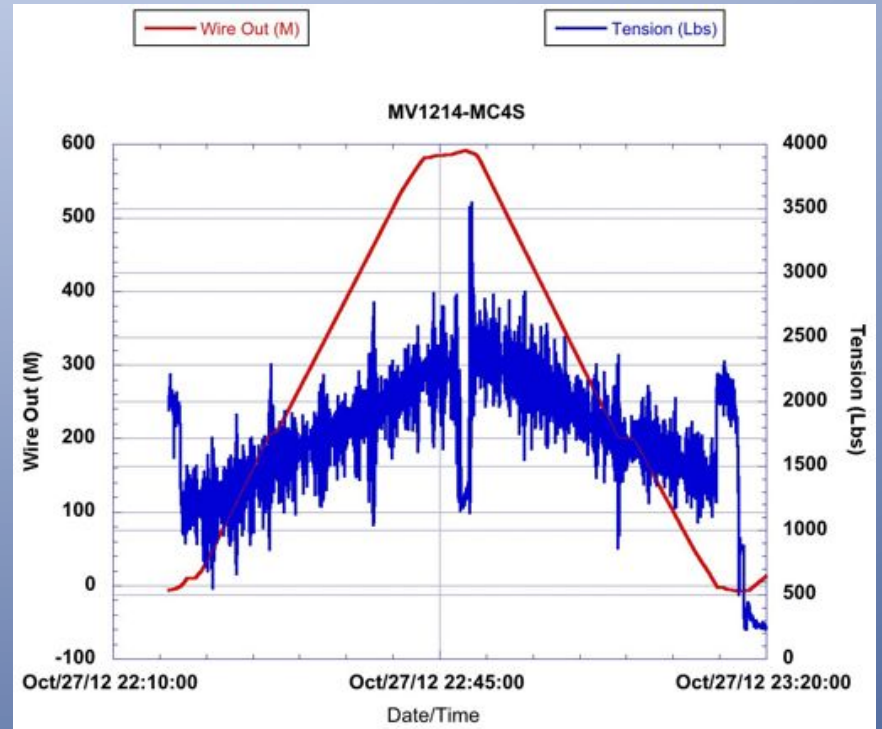
Examples of time-series plots of wire out & tension using 0.680" coax cable.

Pull-out tensions at ~<600 m depth for SB Basin sediments averaged between 1600-2000 lbs.

MC-800 system on CTD wire at depth = ~1300 lbs

MC-800 system on coax 680 wire at depth = ~2200 lbs

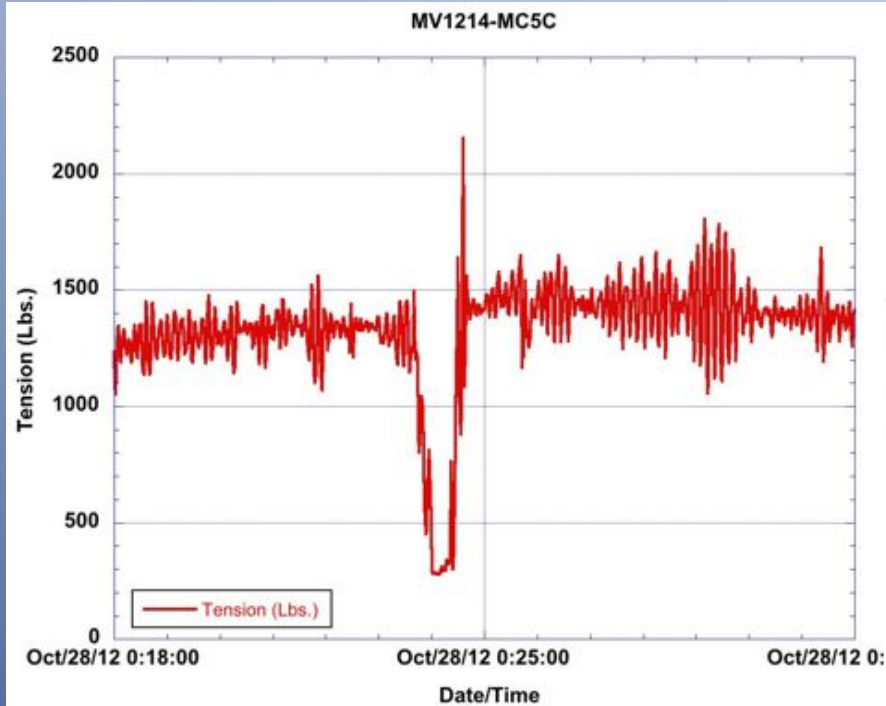
Examples of time-series plots of tension using 0.322" CTD cable.

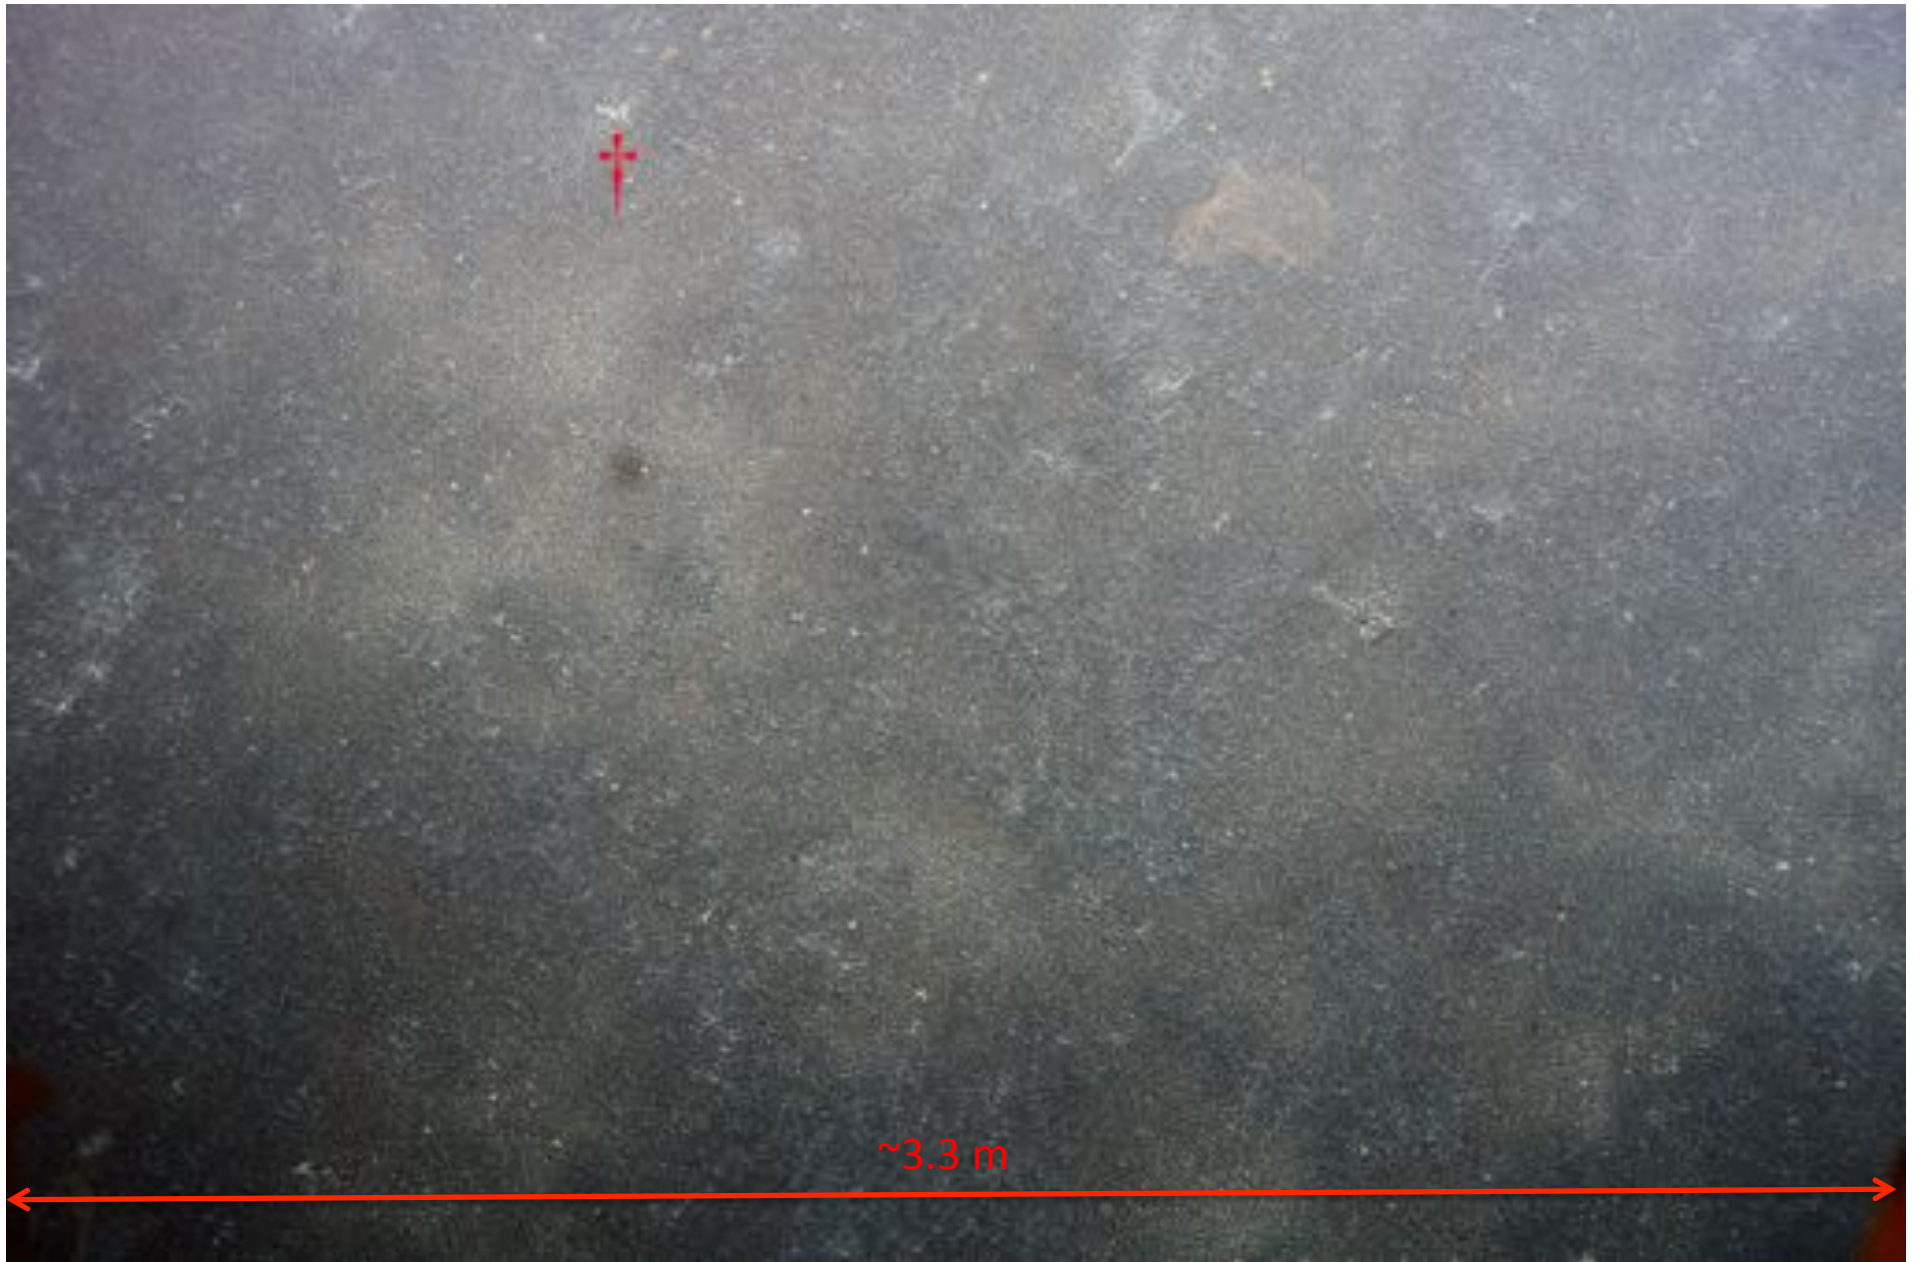
Seafloor photo on bottom approach 16:40:04Z MC-7S ~3 m altitude 571 m depth
(OIS 16 megapixel domed camera - 4928 x 3264 pixels 57° H/40°V) UNOLS – RVTech Feb. 2013

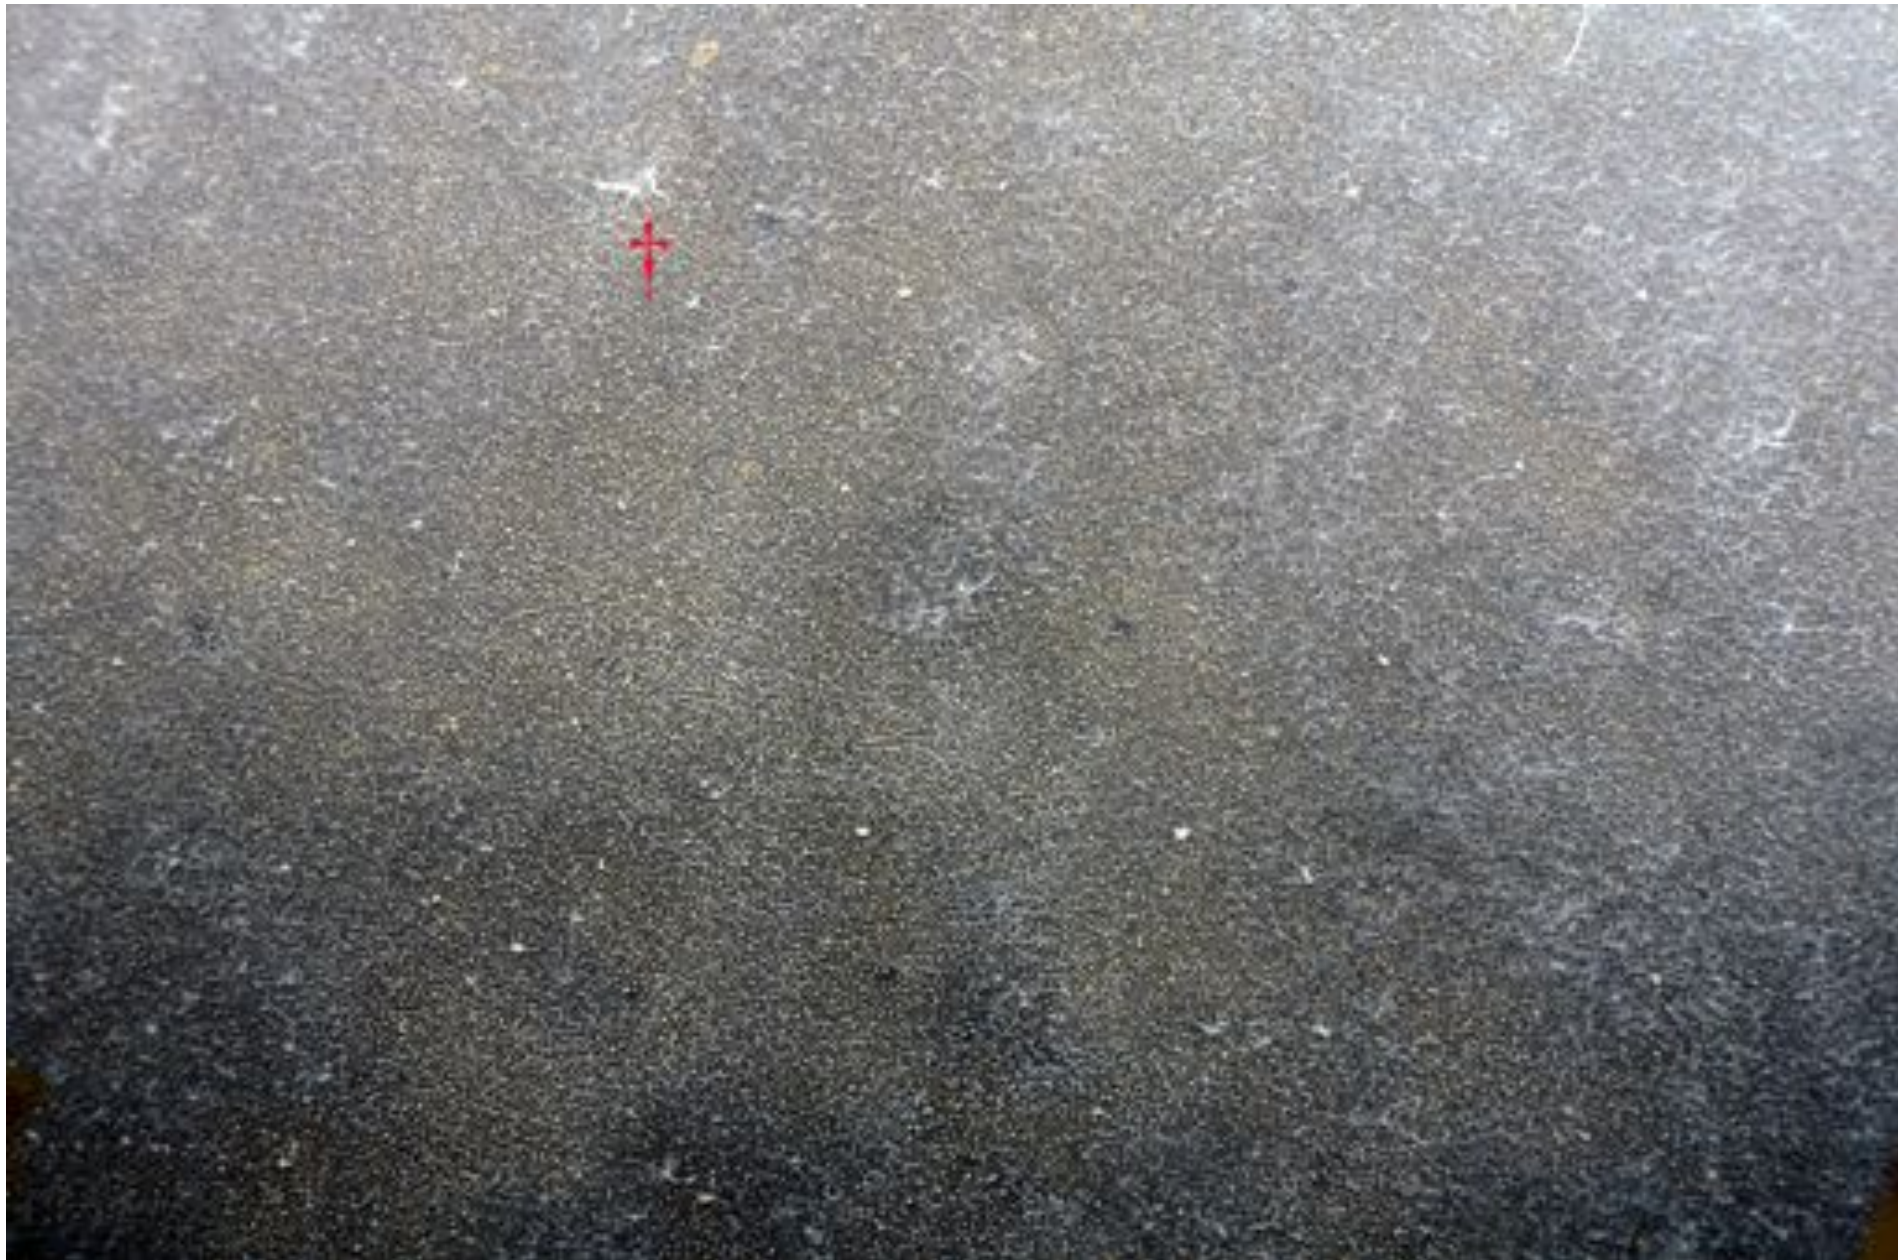
Seafloor photo on bottom approach 16:40:44Z MC-7S ~1.7 m altitude

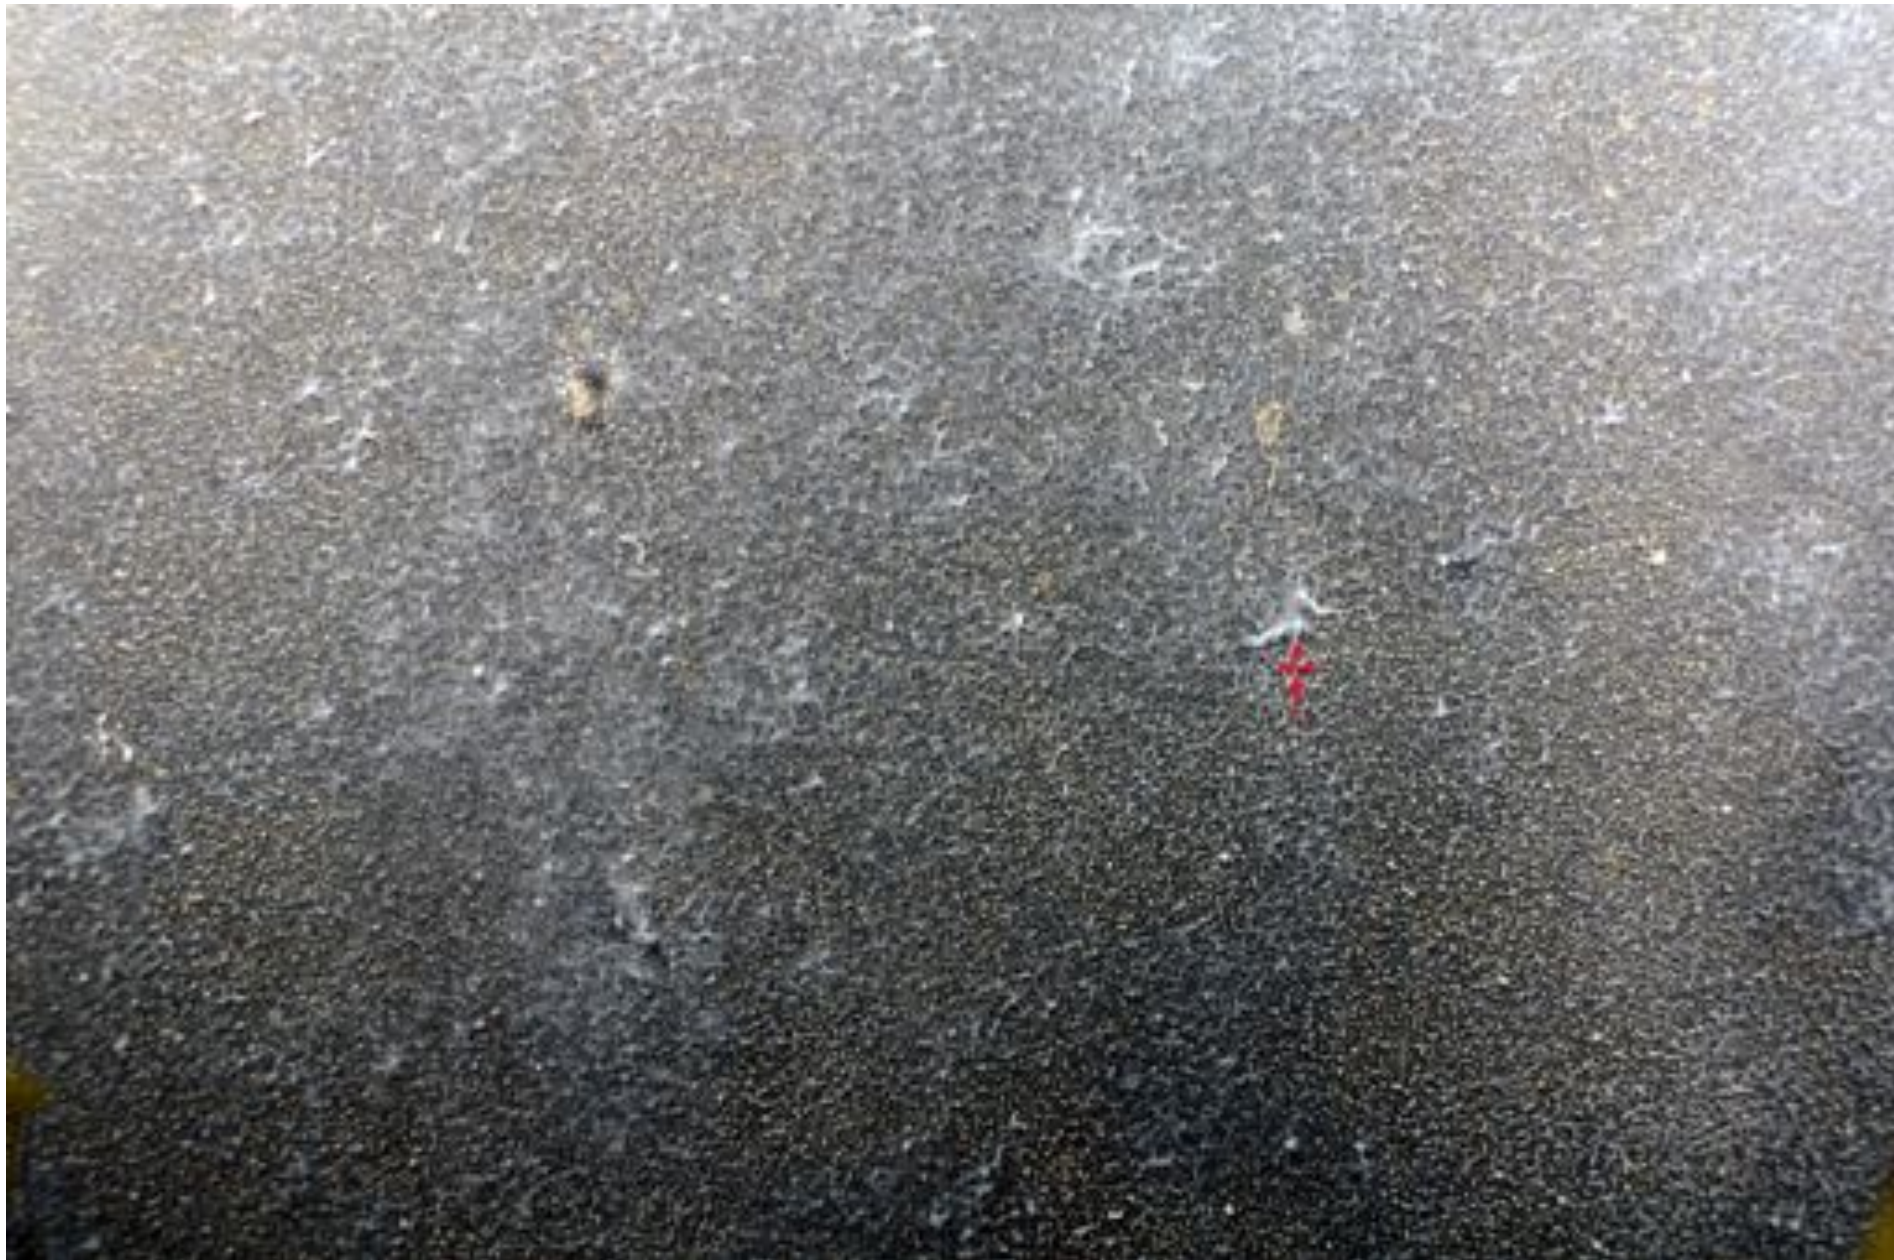
Seafloor photo on bottom approach 16:41:24Z MC-7S ~0.8 m altitude

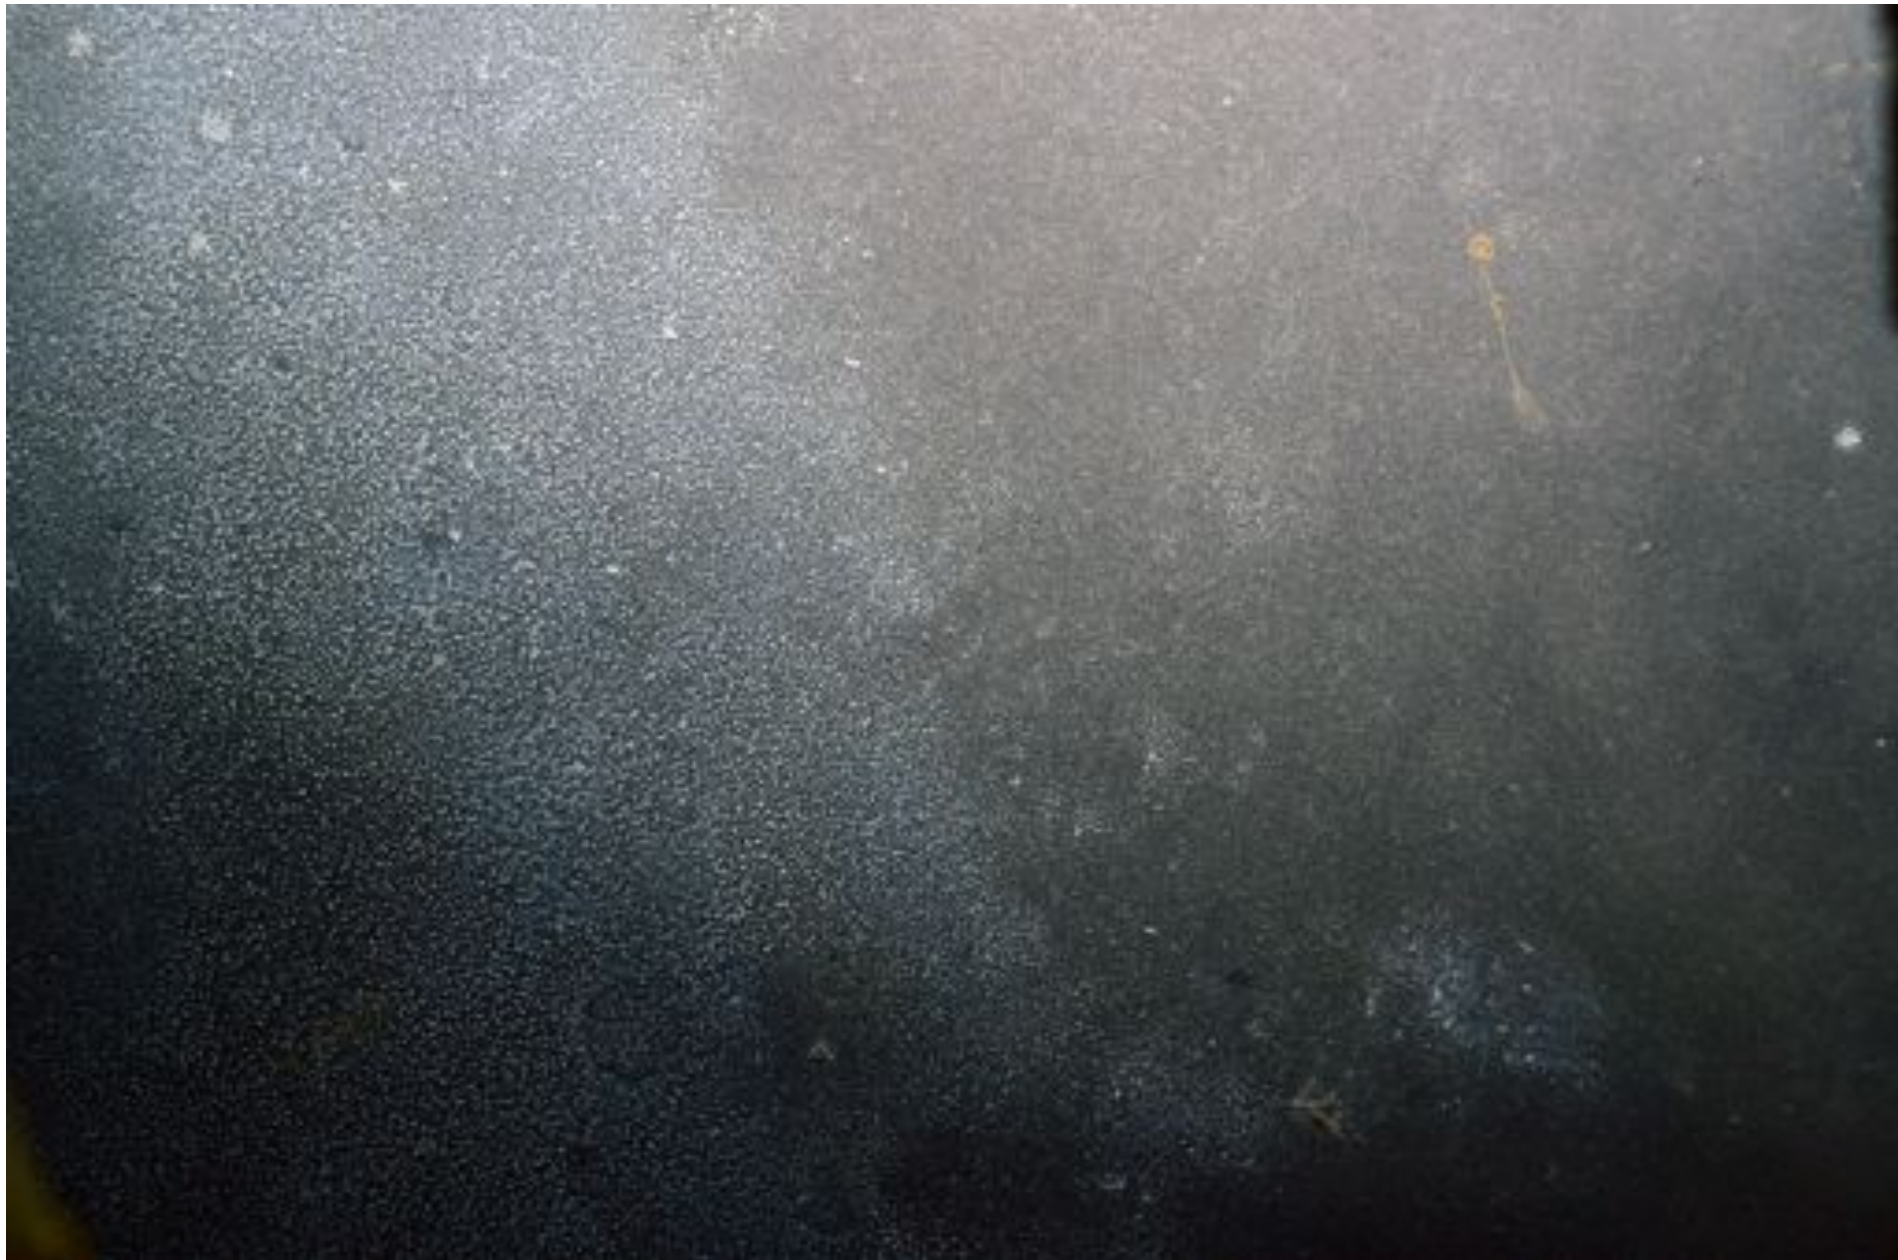
Seafloor photo on bottom approach 23:40:42Z MC-13C ~1.4 m altitude

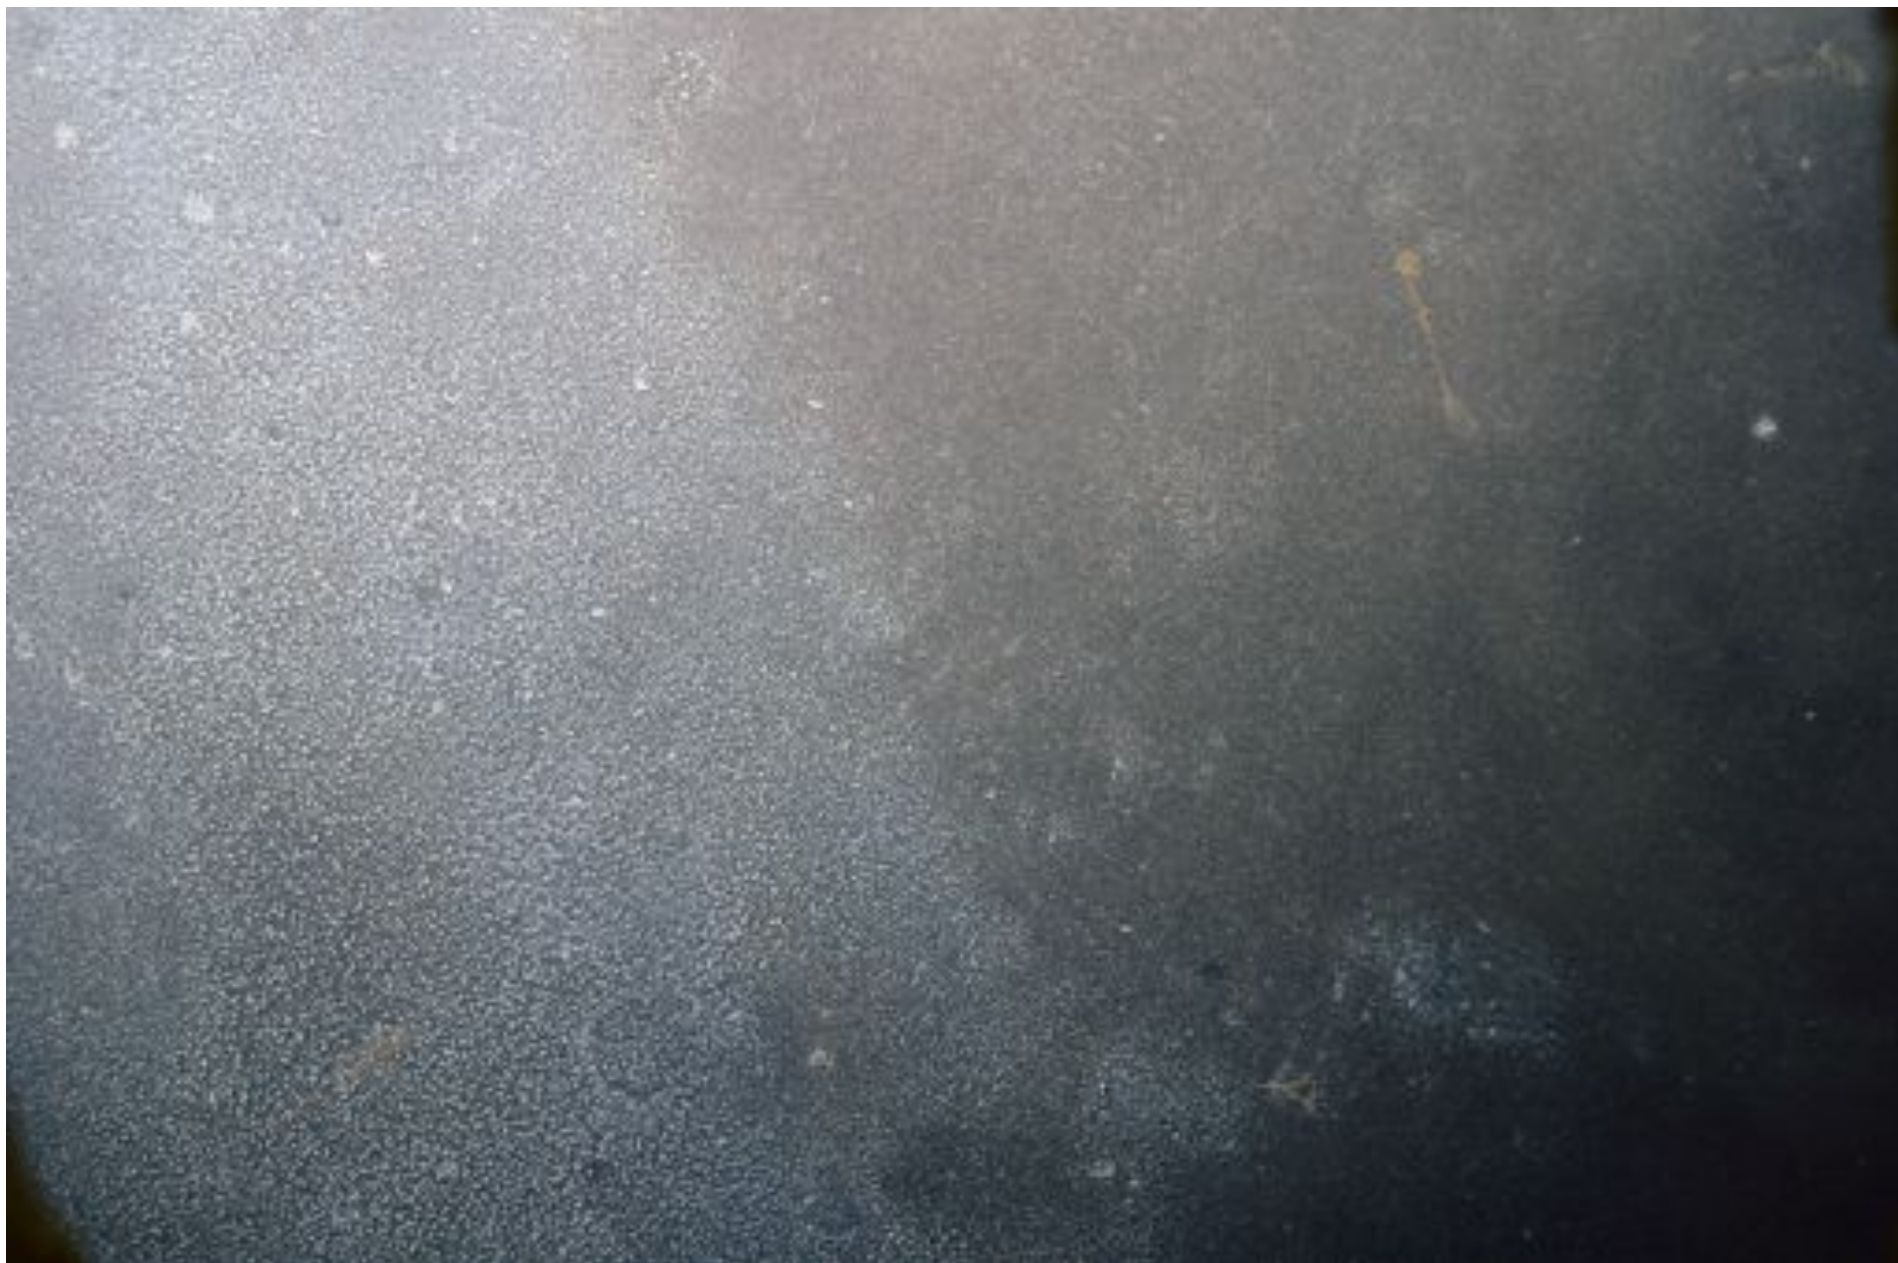
Seafloor photo on bottom approach 23:40:52Z MC-13C ~2 m altitude

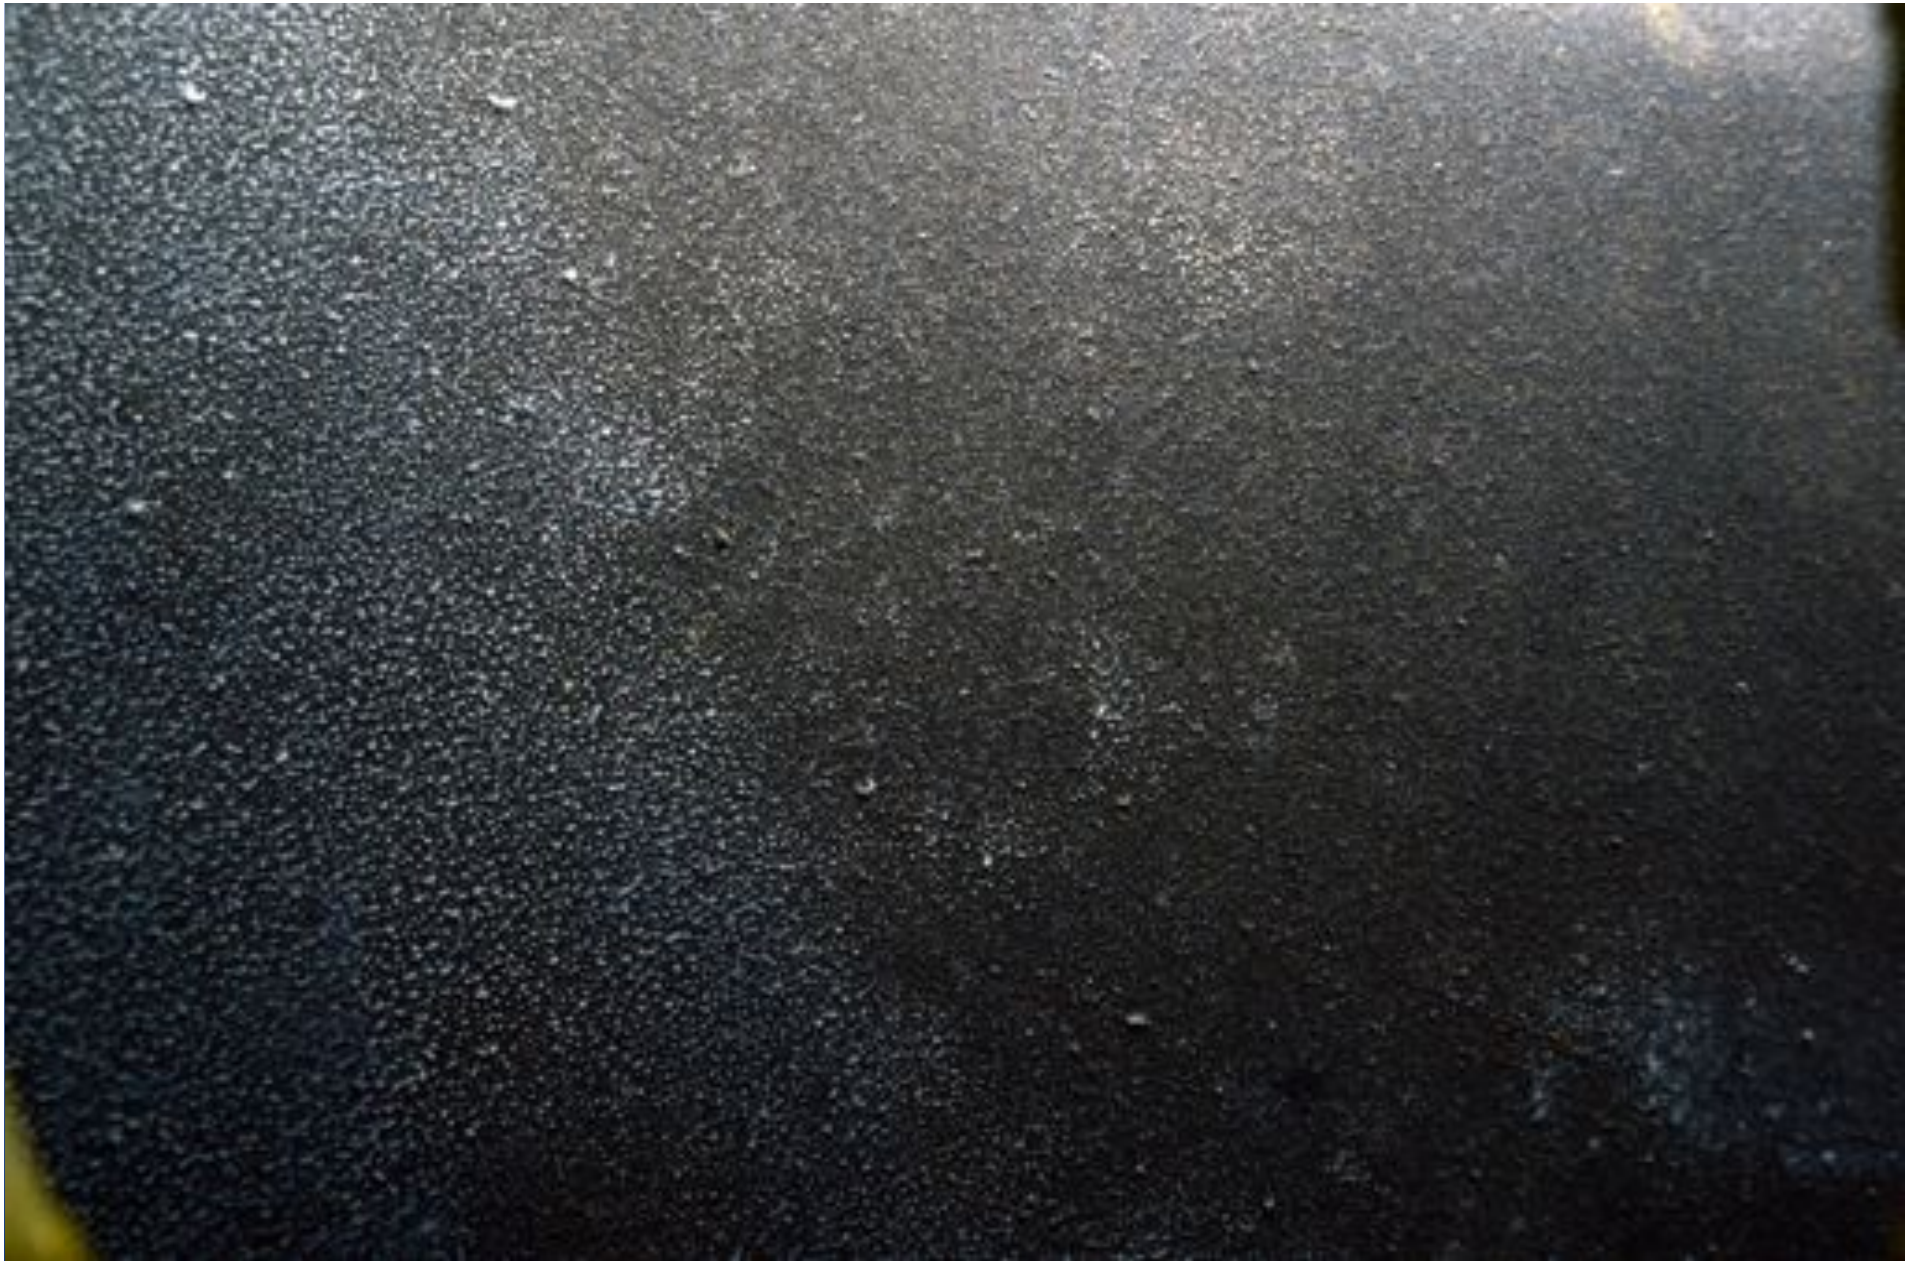
Seafloor photo on bottom approach 23:41:02Z MC-13C ~1.4 m altitude

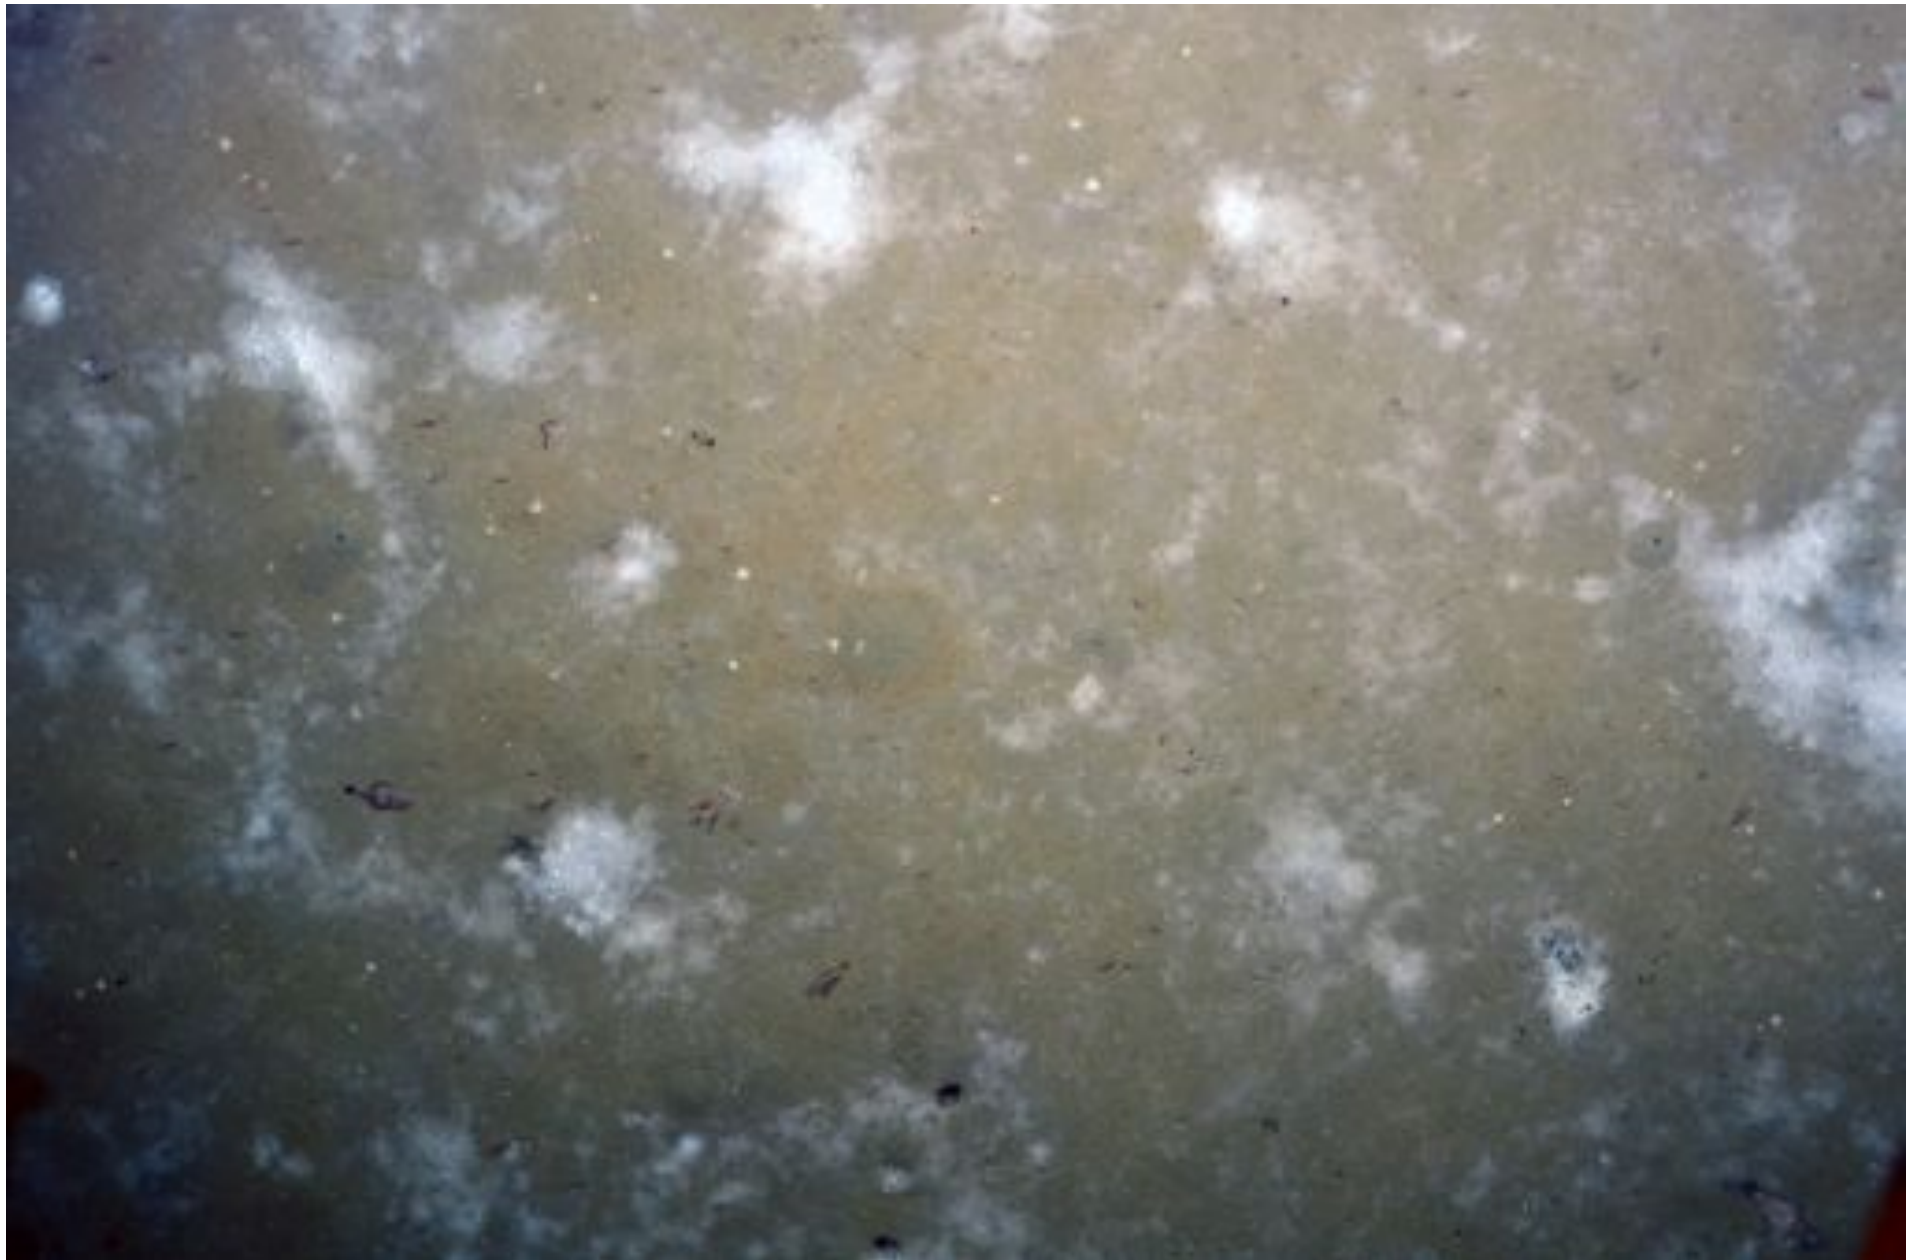
Seafloor photo on bottom approach 19:25:00Z MC-16S ~3 m altitude 470 m depth
Spotchy seeps, note fish and small orange gastropods – above anoxic zone

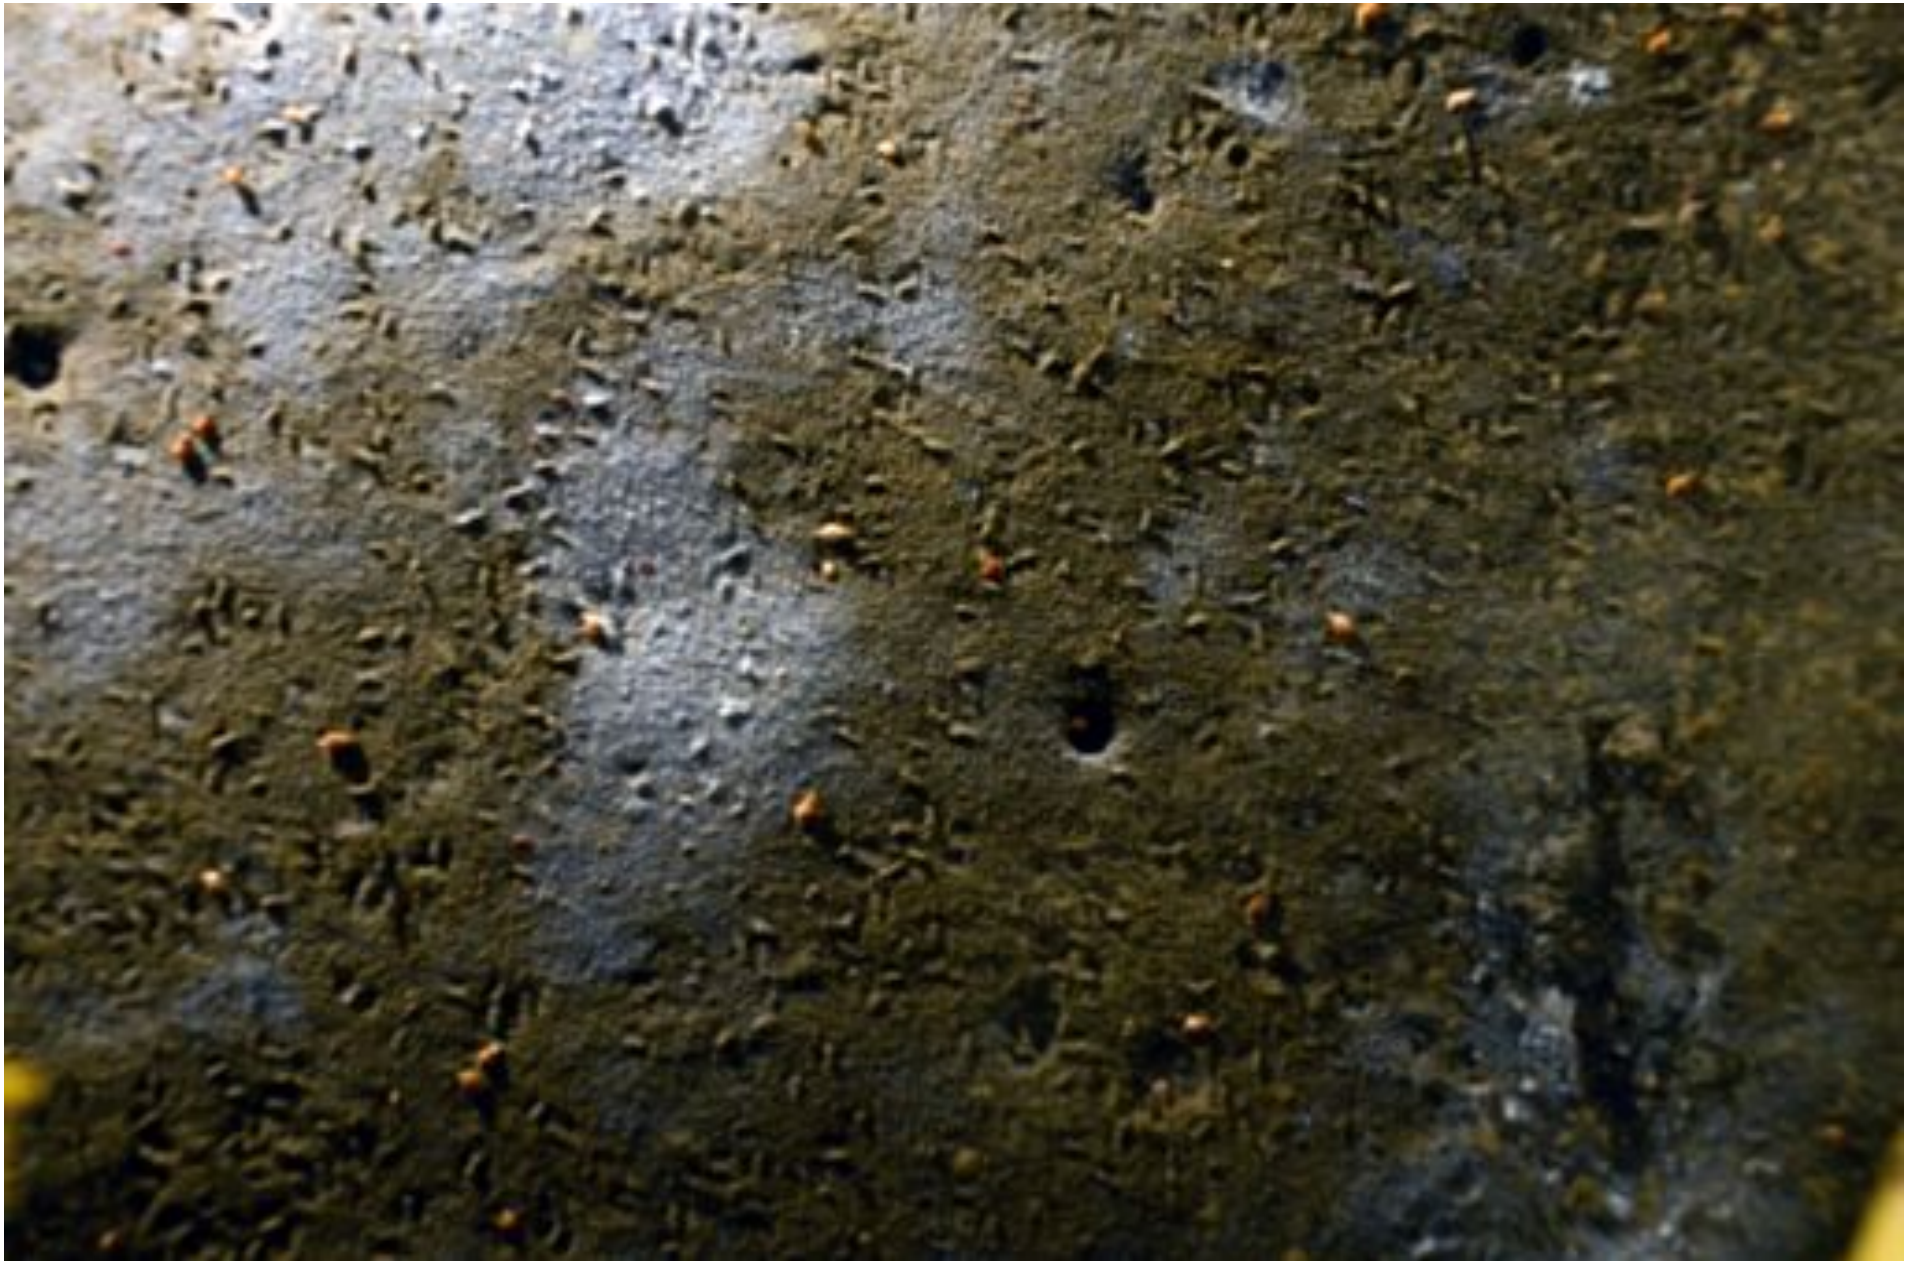
Seafloor photo on bottom approach 19:27:30Z MC-16S ~0.5 m altitude
