*MC-800 Multicorer
with Real-Time
Camera, CTD and
Water Sampling
Capability for the
UNOLS Community*

Dan Fornari
Joan Bernhard
Ginny Edgcomb
WHOI

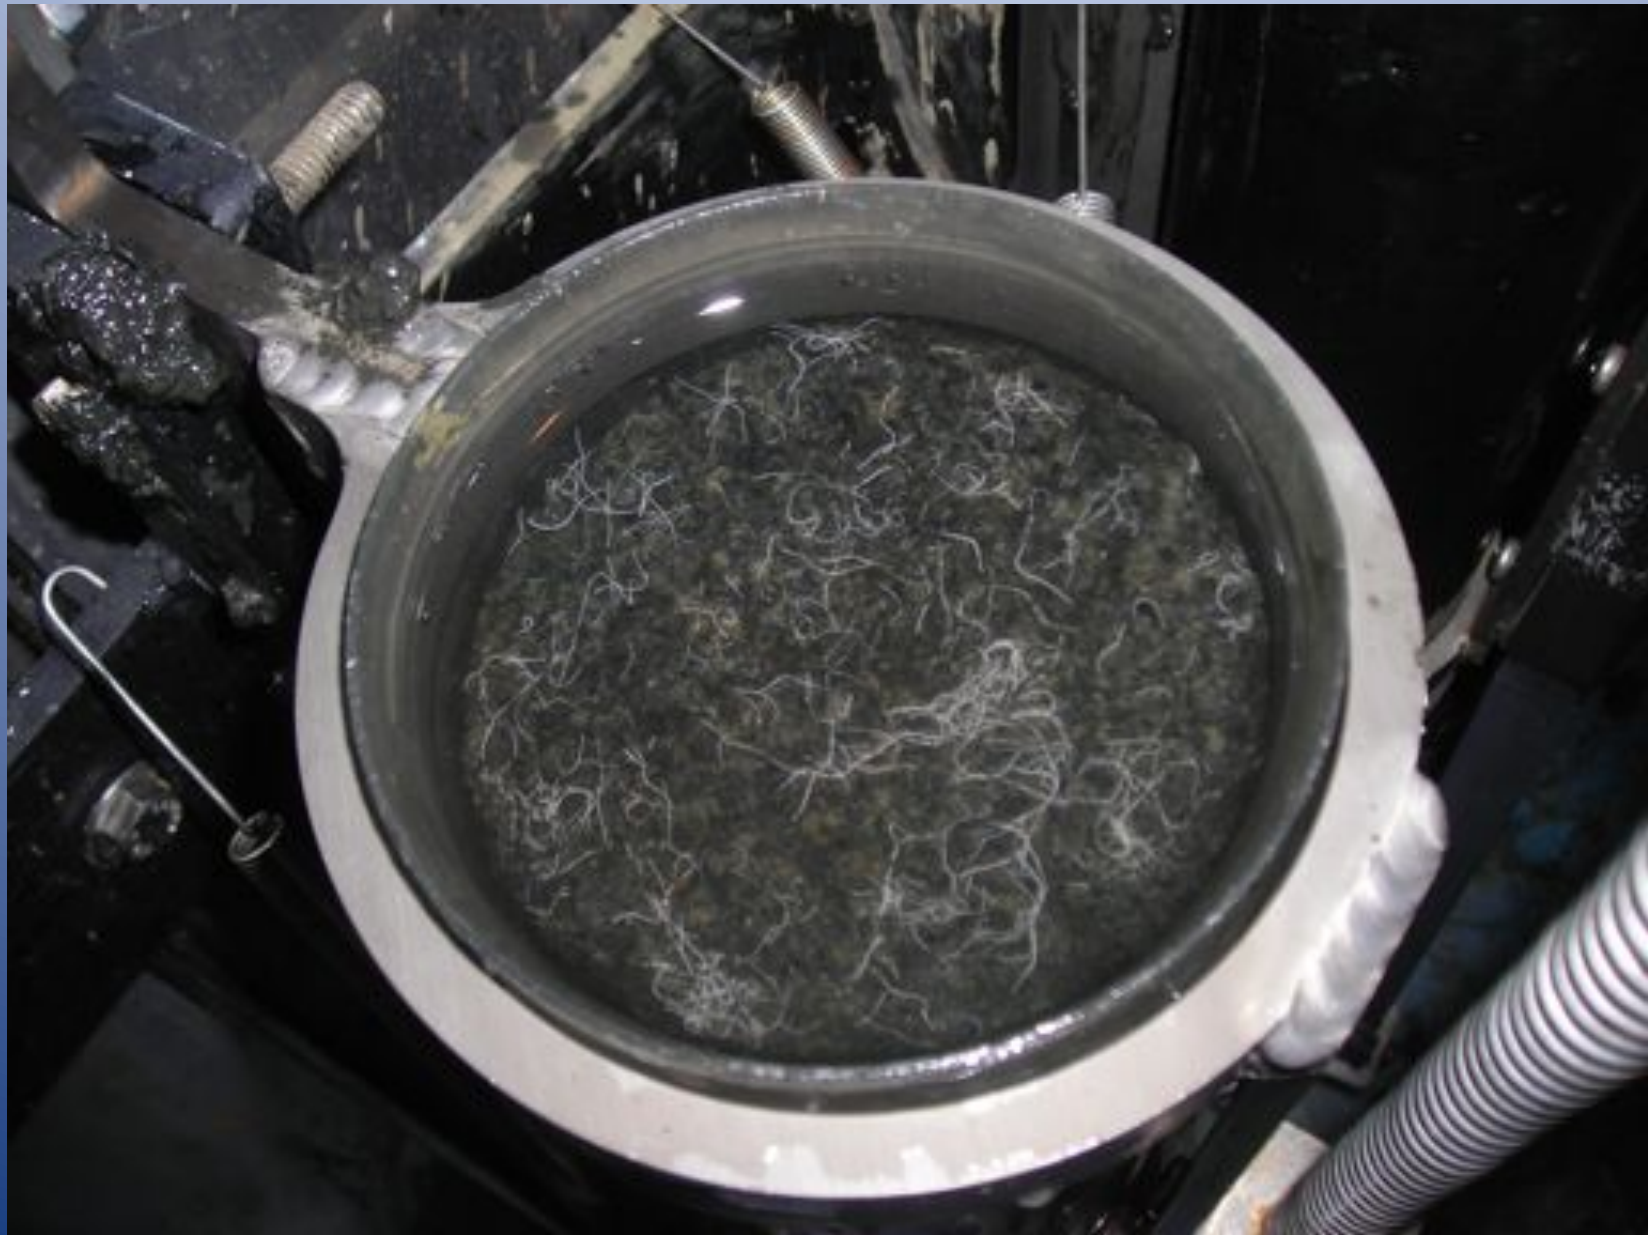
Core top photo MC-12C showing filamentous sulfur-oxidizing bacteria

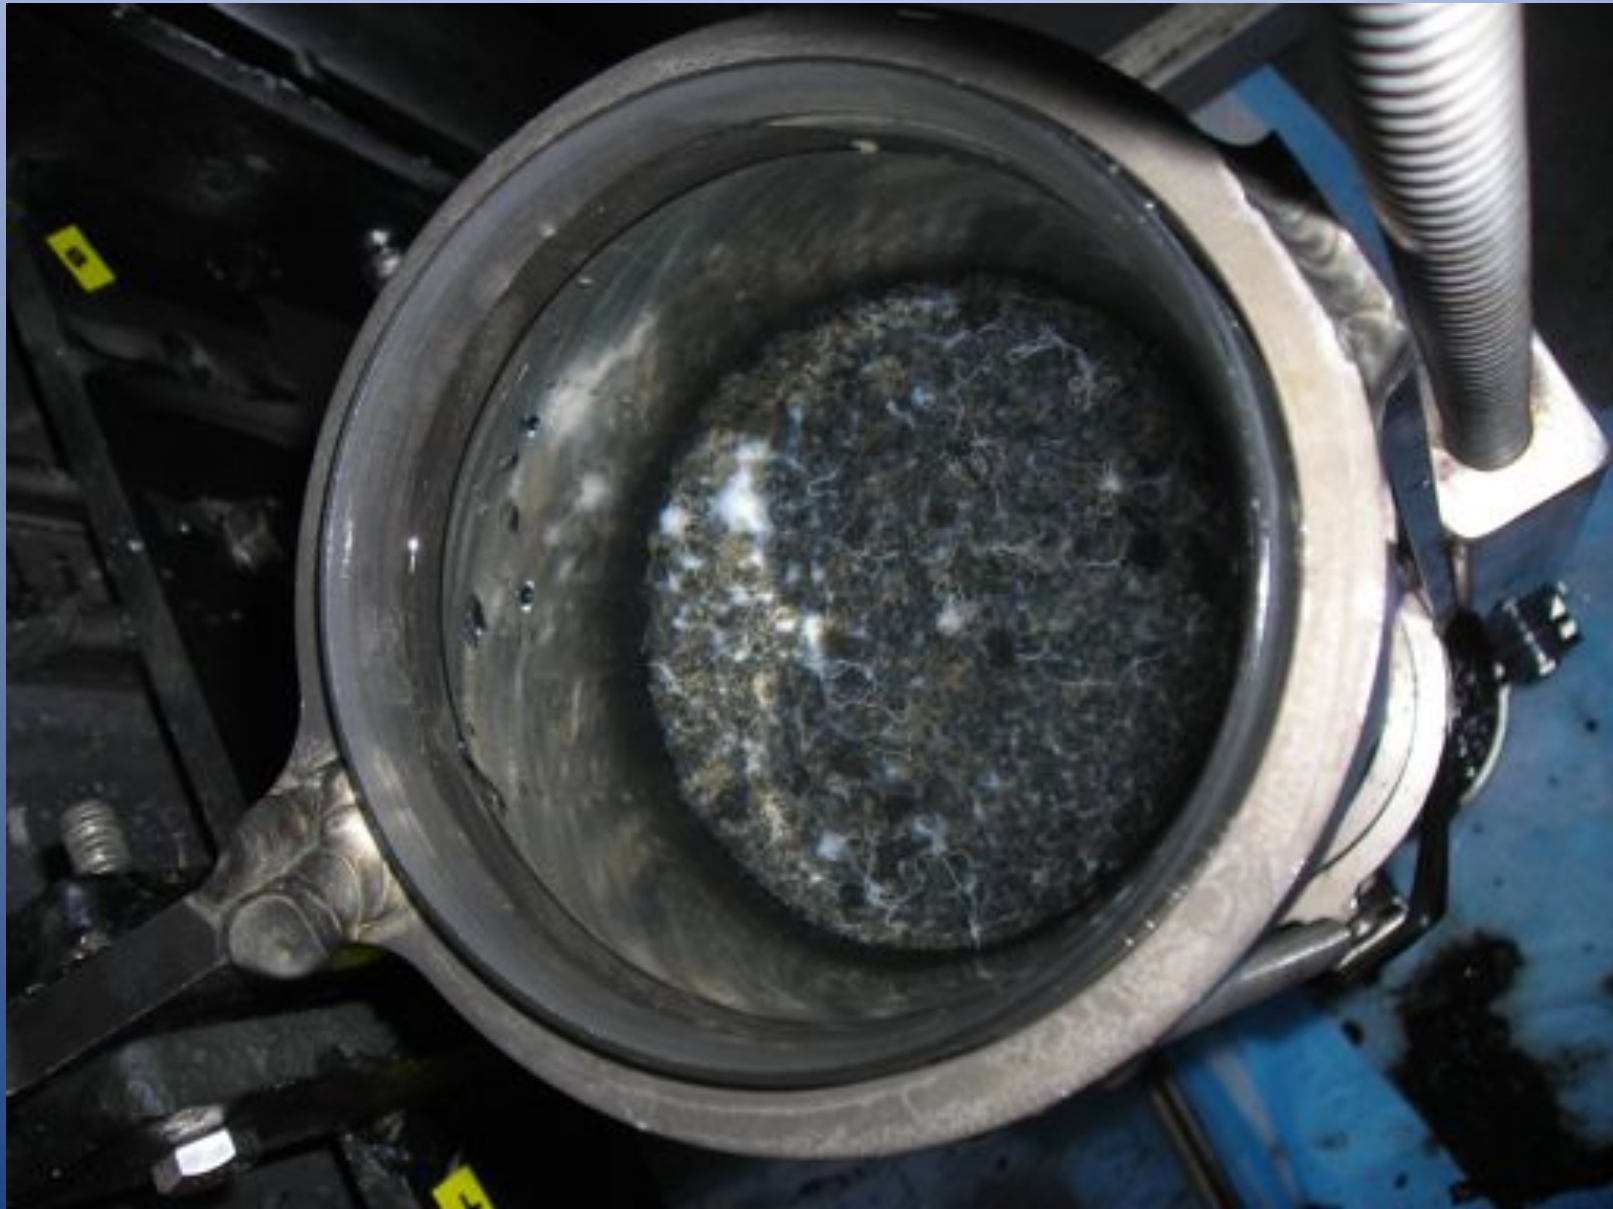
Core top photo MC-13C showing filamentous sulfur-oxidizing bacteria

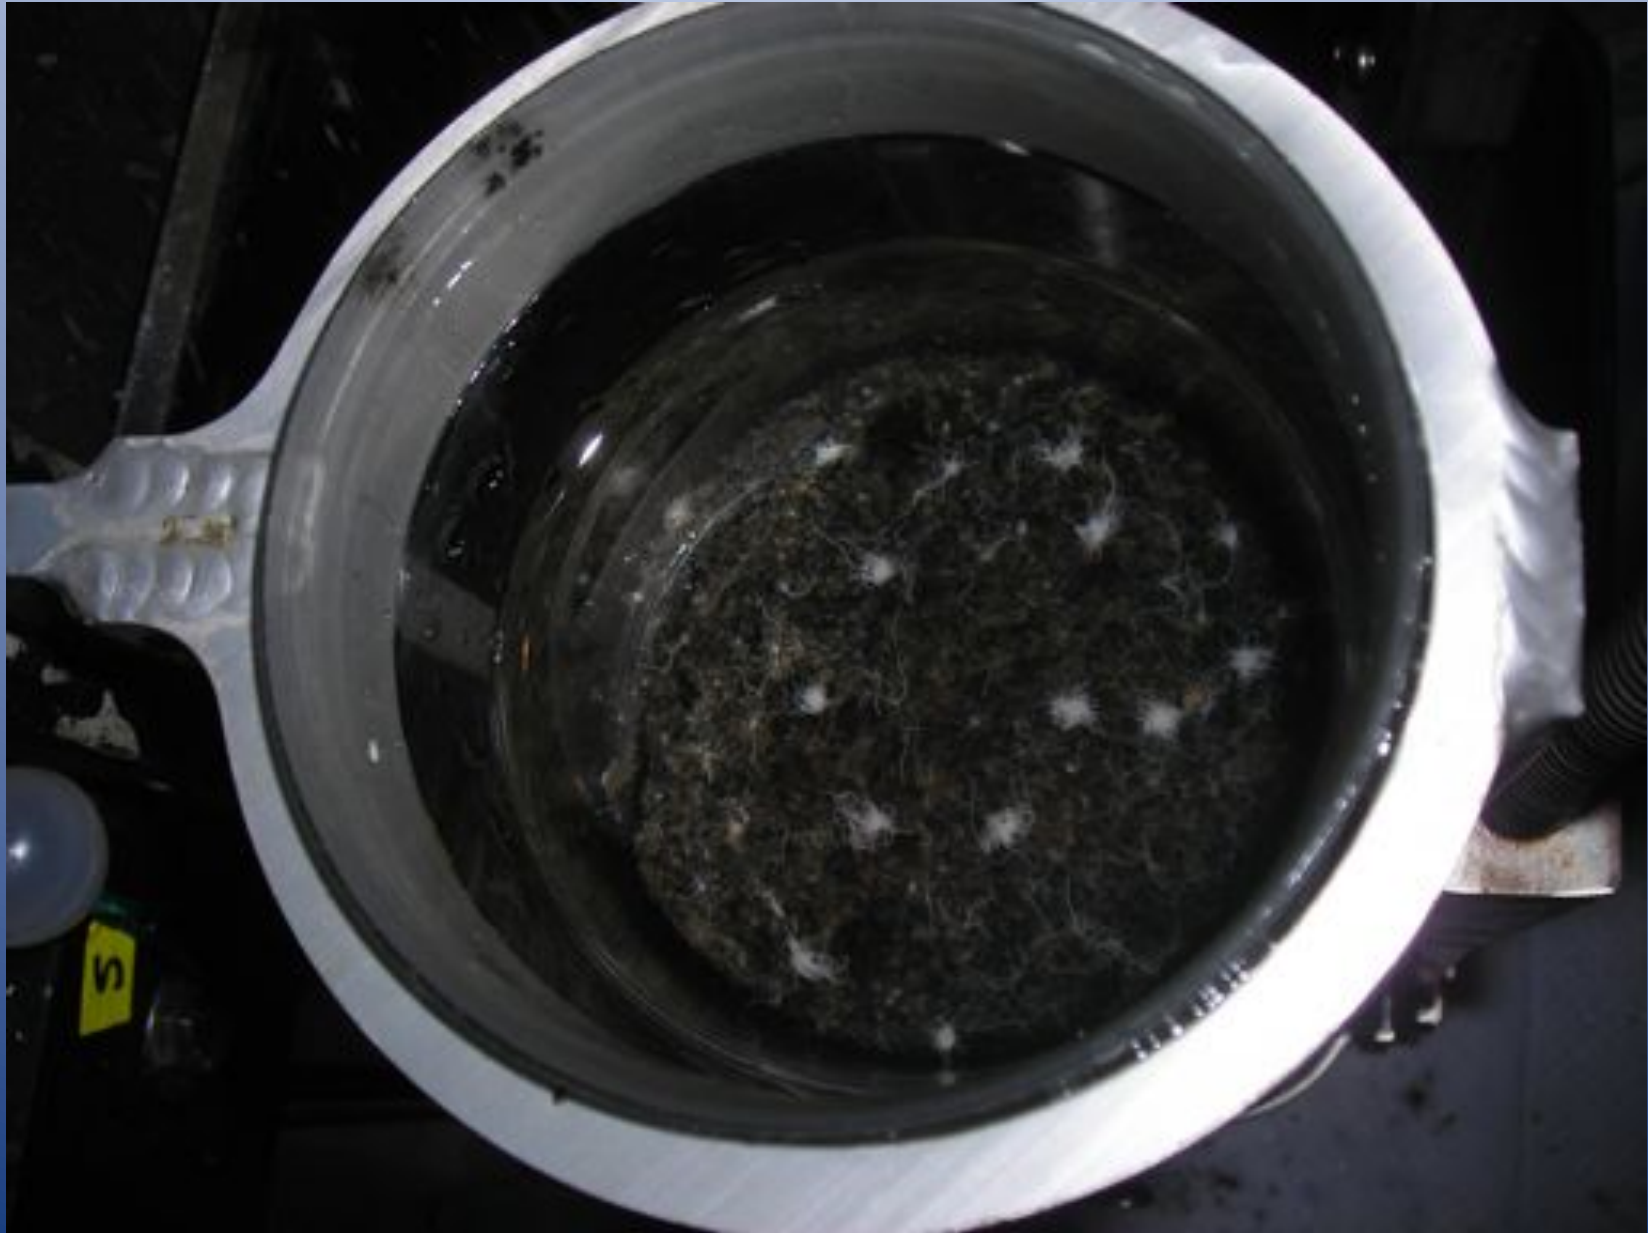
Core top photo MC-14C showing filamentous sulfur-oxidizing bacteria

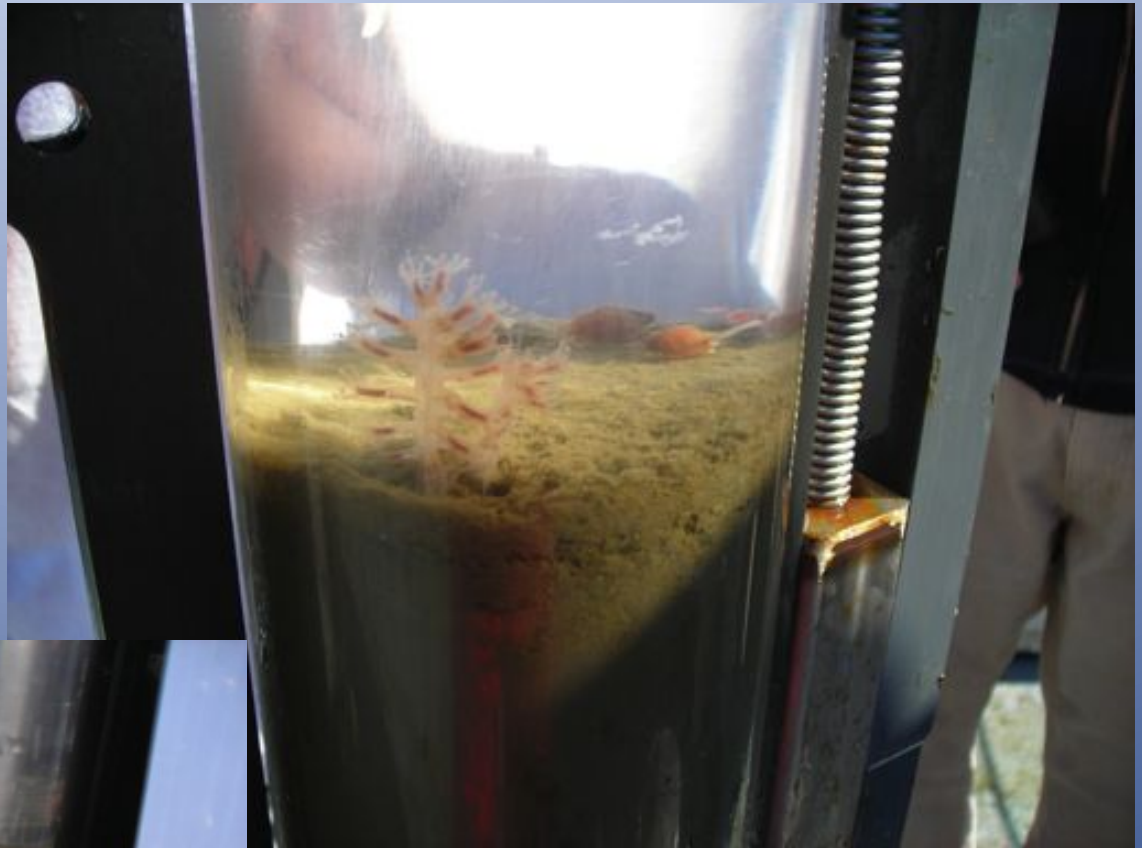
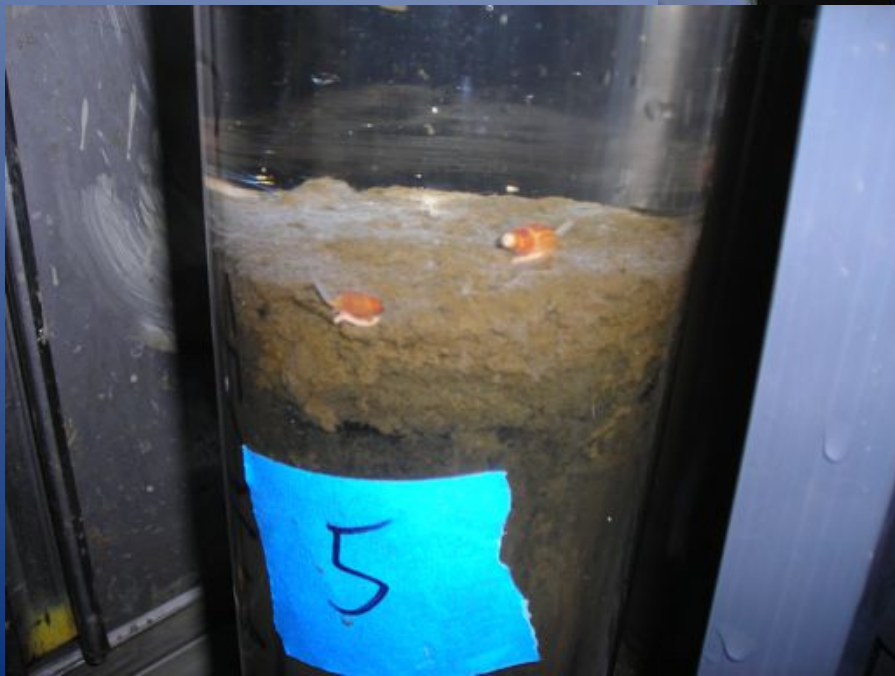
Core top photos MC-16S

Note gastropods also seen in bottom photos
