SWAB REPORT # 731

SWAB DATE: 25 July 2014

*R/V New Horizon*

REPORT FOR SWAB # 731

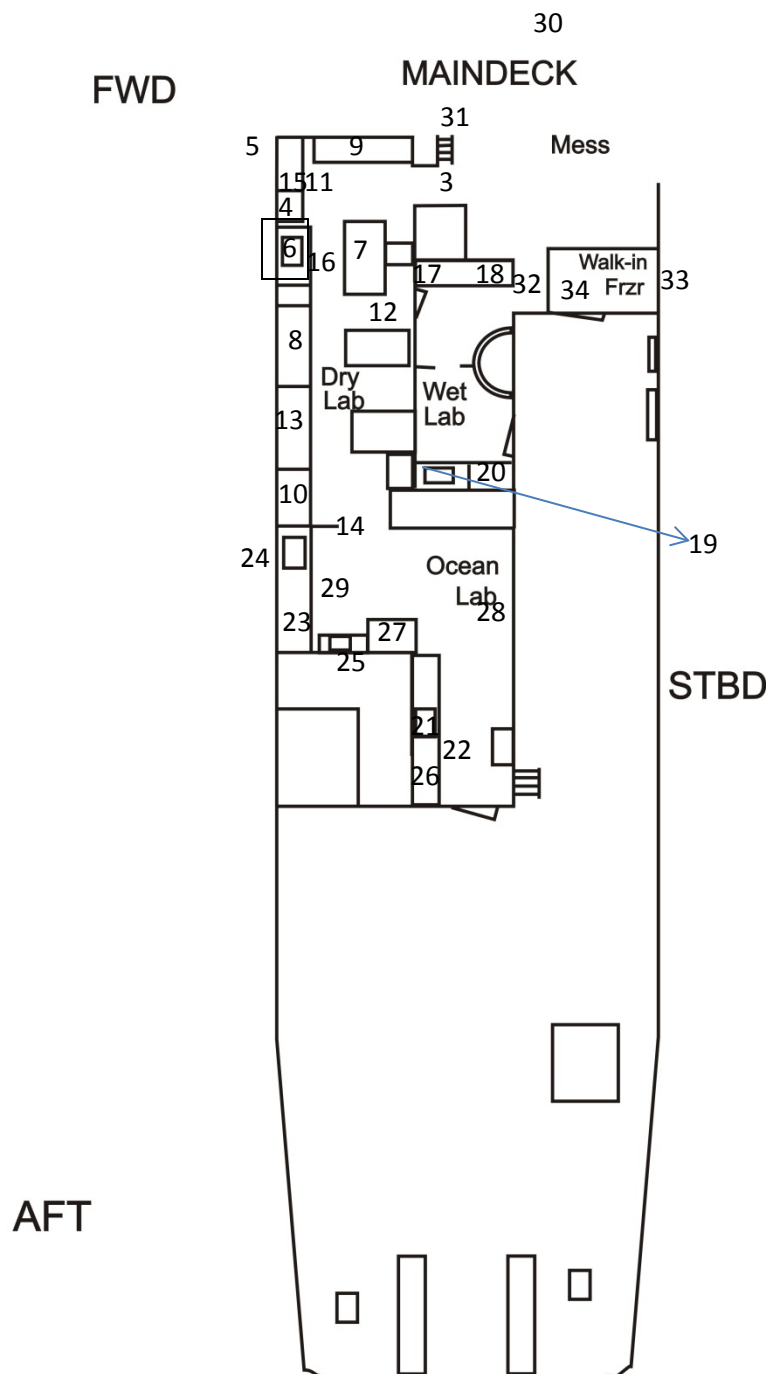
Figure 1

Sample #	Sample Identification	<sup>3</sup> H dpm/m <sup>2</sup>		<sup>14</sup> C dpm/m <sup>2</sup>	
		activity	error	activity	error
1	1st Vial Bkgnd	0	± 0	0	± 0
2	Initial bucket blank	0	± 0	24	± 44
	<u>Main Lab (Figure 1)</u>				
3	Deck outside forward entrance	0	± 0	8	± 63
4	Inside Norland refrigerator	0	± 0	0	± 0
5	Top of -80 freezer	0	± 0	15	± 51
6	Port sink area	0	± 0	7	± 73
7	Benches across from port sink	0	± 0	11	± 107
8	Port benchtop aft of sink	0	± 0	0	± 0
9	Inside chest freezer	0	± 0	13	± 54
10	Aft port benchtop	0	± 0	8	± 123
11	Deck in front of -80 freezer	0	± 0	16	± 54
12	Deck at entrance to wetlab	0	± 0	0	± 0
13	Port benchtop below aft porthole	0	± 0	13	± 63
14	Deck at aft entrance to Ocean Lab	0	± 0	8	± 74
15	Inside of chest freezer	0	± 0	0	± 0
16	Deck in front of sink	0	± 0	0	± 0
	<u>Wet Lab (Figure 1)</u>				
17	Forward port benchtop	0	± 0	17	± 49
18	Foward starboard benchtop	0	± 0	23	± 47
19	Aft sink area and benchtop	0	± 0	4	± 0

20	Benchtop next to sink	0	± 0	10	± 64
	<u>Ocean Lab (Figure 1)</u>				
21	Aft port sink area next to fume hood	0	± 0	0	± 0
22	Deck below fume hood and sink	0	± 0	0	± 0
23	Benchtop aft of port forward sink	0	± 0	9	± 103
24	Port forward sink area	0	± 0	14	± 58
25	Aft sink area	0	± 0	7	± 259
26	Inside fume hood	0	± 0	20	± 54
27	Benchtop starboard of aft sink	0	± 0	1	± 0
28	Benchtop under stbd porthole	0	± 0	0	± 0

Sample #	Sample Identification	<sup>3</sup> H dpm/m <sup>2</sup>		<sup>14</sup> C dpm/m <sup>2</sup>	
		activity	error	activity	error
29	Benchtop opposite of aft sink	0	± 0	6	± 0
	<u>Miscellaneous Areas (Figure 1)</u>				
30	Mess deck in front of hot food server	0	± 0	0	± 0
31	Mess deck outside lounge entrance	0	± 0	0	± 0
32	Mess deck in front of aft door	0	± 0	9	± 95
33	Walk-In freezer - Deck	0	± 0	8	± 67
34	Benchtop across from sink	0	± 0	3	± 0
35	Final bucket blank	0	± 0	17	± 56

Please note that the error reported for each isotope is the two-standard deviation counting error. All areas tested were free from radioisotope activity that requires cleaning.
