Healy SEAFAC Radiated Noise

September 3, 2014 Ketchikan, Alaska

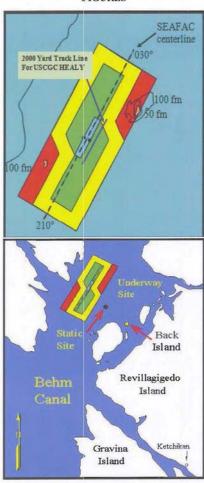
Figure 1. Southeast Alaska Acoustic Measurement Facility

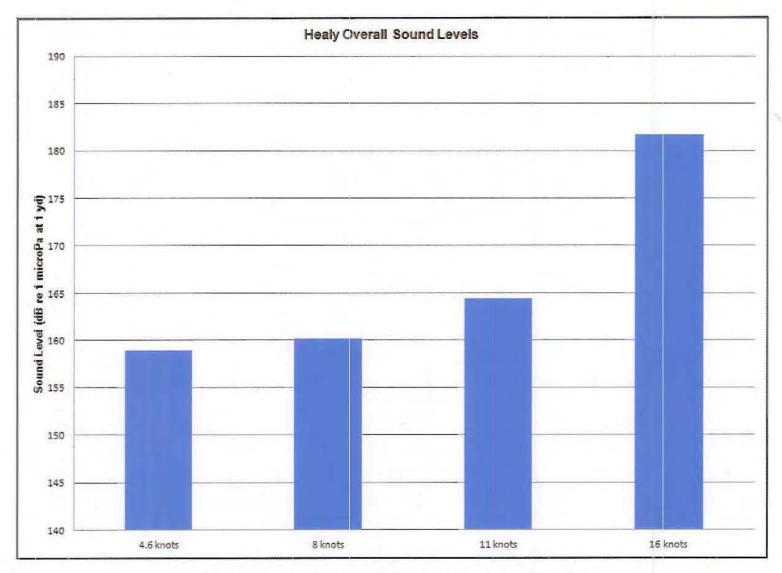
Figure 3. Healy Overall Sound Levels by Speed

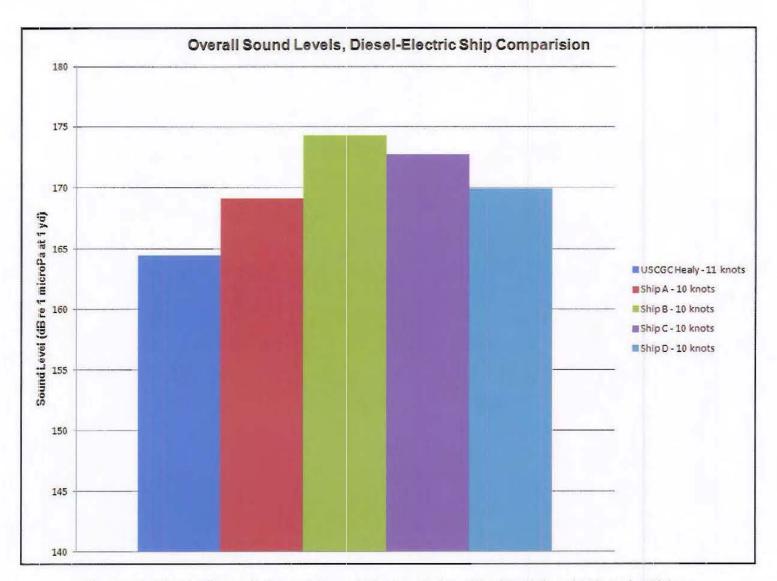
Figure 4. Healy Overall Sound Level Compared to Similar Diesel-Electric Ships

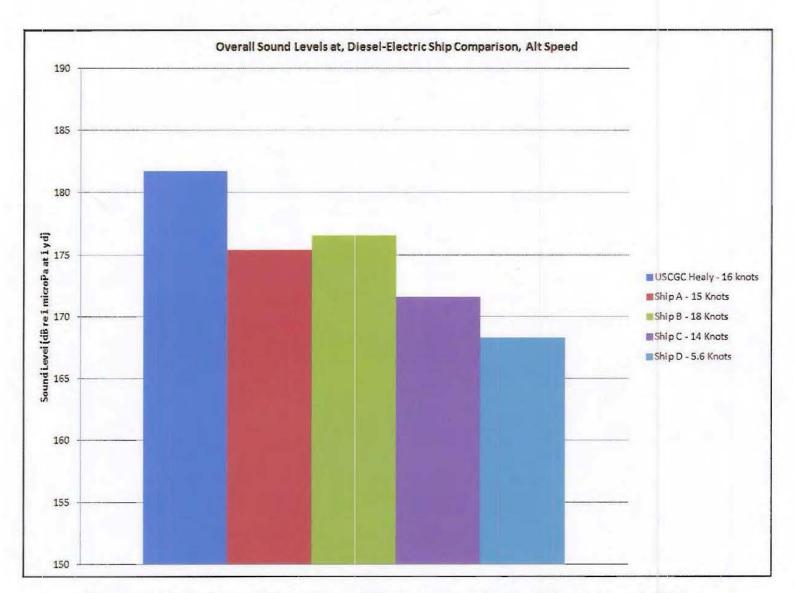
Figure 5. Healy Overall Sound Level Compared to Similar Diesel-Electric Ships, Alternate Speed

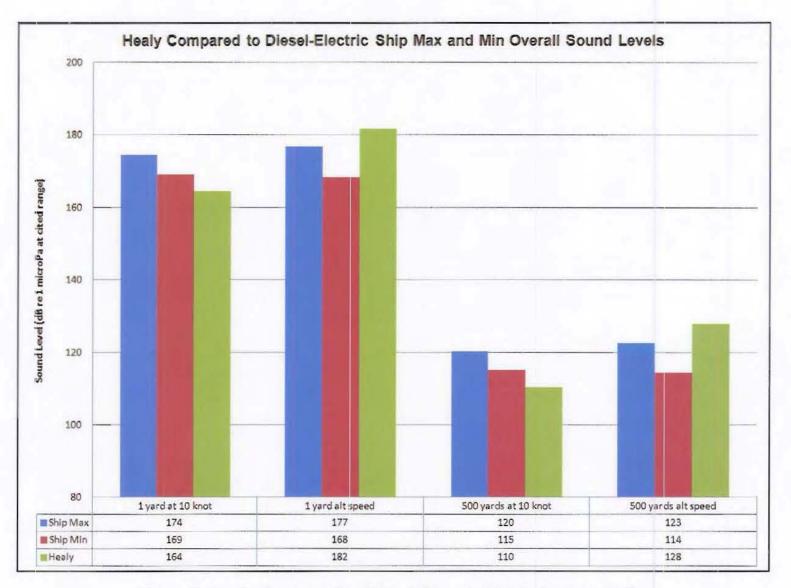
Figure 7. Healy Compared to Diesel-Electric Ship's Max and Min Overall Sound Levels at Range and Speed
