### **SWAB REPORT #837**

SWAB DATE: 28 October 2016

R/V Oceanus

LOCATION: Newport, OR
VESSEL: R/V Oceanus

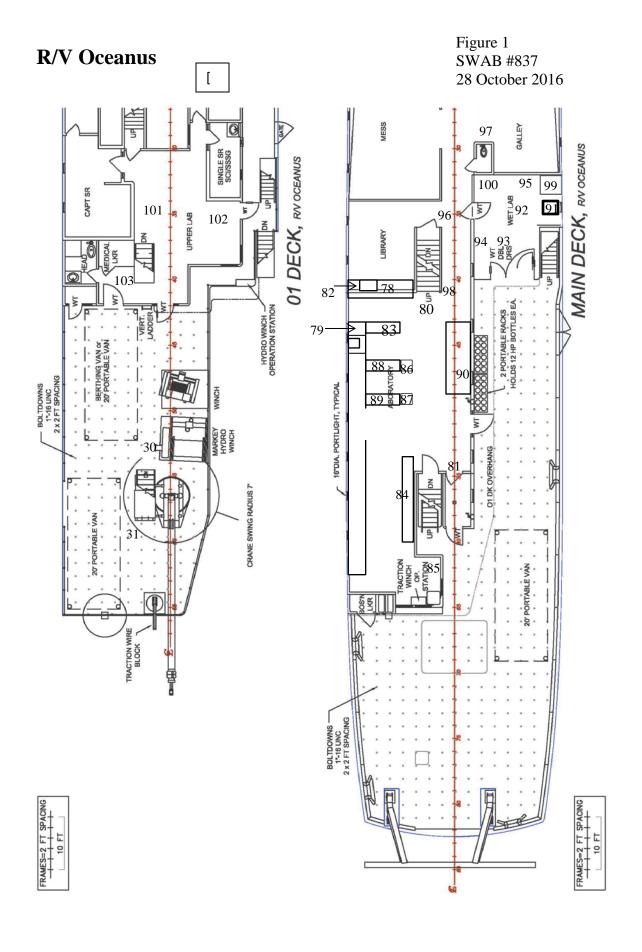
Sample # Sample Identification	<sup>3</sup> H dpn	<sup>3</sup> H dpm/m <sup>2</sup>			<sup>14</sup> C dpm/m <sup>2</sup>		
	activity	(	error	activity		error	
1 1st Vial Bkgnd	0	±	0	0	±	0	
67 Initial bucket blank CO #2	37	±	50	-7	土	24	
Main Lab (Fig. 1)							
78 Bench top adjacent to sink	49	$\pm$	50	-7	$\pm$	21	
79 Inside forward port refrigerator	36	$\pm$	76	-32	$\pm$	53	
80 Deck near forward stairs	11	$\pm$	31	11	$\pm$	35	
81 Deck by aft entrance	-1	$\pm$	0	-20	$\pm$	33	
82 Forward sink area	7	$\pm$	19	-14	$\pm$	23	
83 Bench top next to forward port refrigerator	-37	$\pm$	0	18	$\pm$	42	
84 Starboard aft bench top	-11	$\pm$	0	-15	$\pm$	26	
85 Deck at winch control station	-7	$\pm$	20	4	$\pm$	40	
86 Top of Whirlpool chest freezer	5	$\pm$	113	-7	$\pm$	22	
87 Top of So-Lo -80°C freezer	-3	±	8	-4	$\pm$	12	
88 Bench top adjacent to -80°C freezer	-10	$\pm$	333	23	$\pm$	38	
89 Bench top adjacent to Whirlpool freezer	-93	$\pm$	128	10	$\pm$	71

90 Starboard workbench	-27	±	55	-17	<u>±</u>	28	
Wet Lab (Fig. 1)							
91 Sink area	39	$\pm$	61	-27	$\pm$	46	
92 Deck in center of lab	23	$\pm$	57	-10	$\pm$	16	
93 Deck by aft door	12	$\pm$	79	-11	$\pm$	19	
94 Port Bench top	22	$\pm$	44	3	$\pm$	26	
95 Starboard forward bench top	9	$\pm$	25	-19	$\pm$	32	
96 Passage between Labrary and Wet Lab	47	$\pm$	77	-40	$\pm$	67	
97 Mess deck in front of hot food station	-12	$\pm$	34	0	$\pm$	1	
98 Deck in passage at forward entrance to M	6	$\pm$	105	-8	$\pm$	13	
99 Inside fume hood	-15	$\pm$	43	22	$\pm$	39	
100 Port forward bench top	-5	<u>±</u>	15	-29	<u>±</u>	48	
01 Deck (Fig. 1)							
101 Deck at top od stairs to Upper Lab	27	$\pm$	80	-24	$\pm$	40	
102 Upper lab deck near starboard outer door	30	$\pm$	64	-16	$\pm$	27	
103 Deck between head and infirmary	39	$\pm$	58	-16	$\pm$	27	
104 Final bucket blank CO #2	18	$\pm$	51	-5	$\pm$	9

Please note that the error reported for each isotope is the two-standard deviation counting error. The reports may now contain values less than zero. When decay counting background samples will be distributed about the background vial, which means that negative values are possible. In the past we rounded the negative values to zero. Values are only significantly above background when they are positive and larger than the error. All areas tested on the ship awere free from any isotope contamination that requires cleaning.
